PCC 322 Truck Mechanical Repair Documentation

August 2023- March 2024

Major surgery after 2+ decades of MSM service

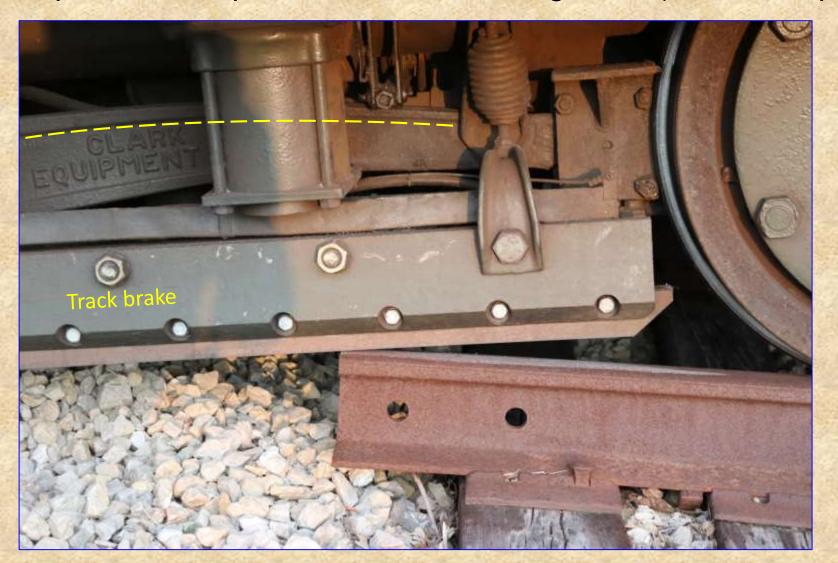
Incident at north end of CHSL line; July 20, 2023

Rear truck, pole side torque arm deformed during dérail (Bill Arends photo)

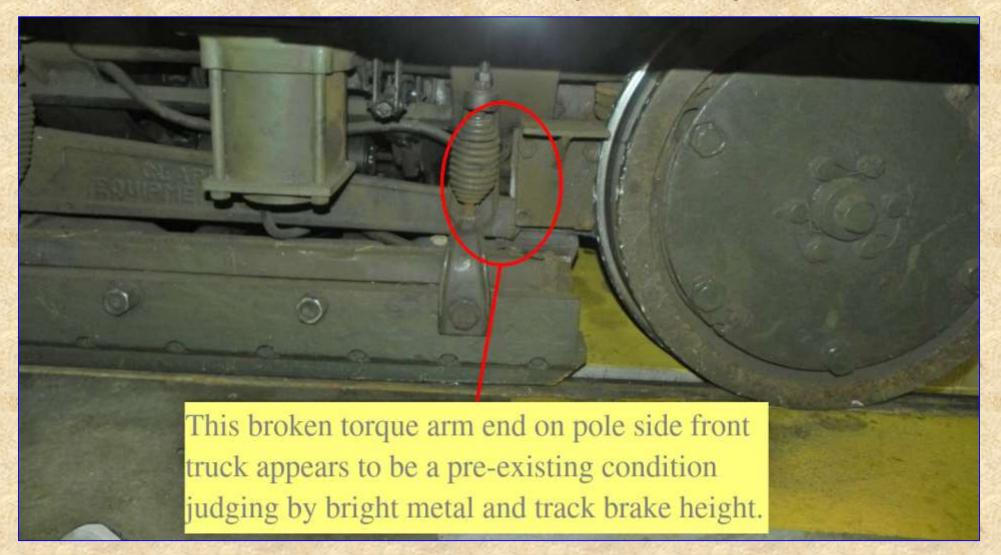
Incident at north end of CHSL line; July 10, 2016

Front truck, pole side damage (Mark Digre)

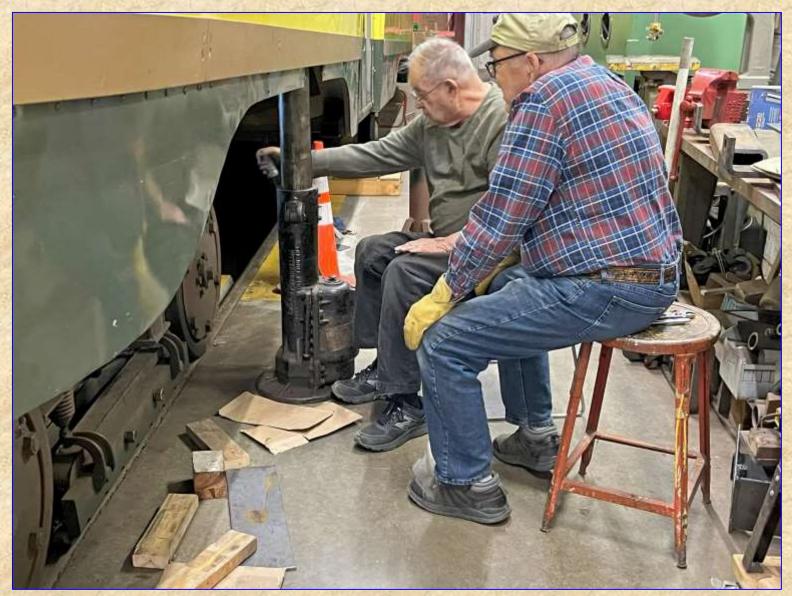
- 1. A shop-made bracket (red outline) hooks over the head of the jack and drops below the bolster at the car sill. The car body is then lifted high enough to insert wood blocking between bolster and truck frame.
- 2. The jack is then let down and the bracket removed.
- 3. The jack is repositioned under the bolster, inboard of the sill and the lift proceeds (see next slide).
- 4. We plan to modify this step to eliminate the offset bracket.

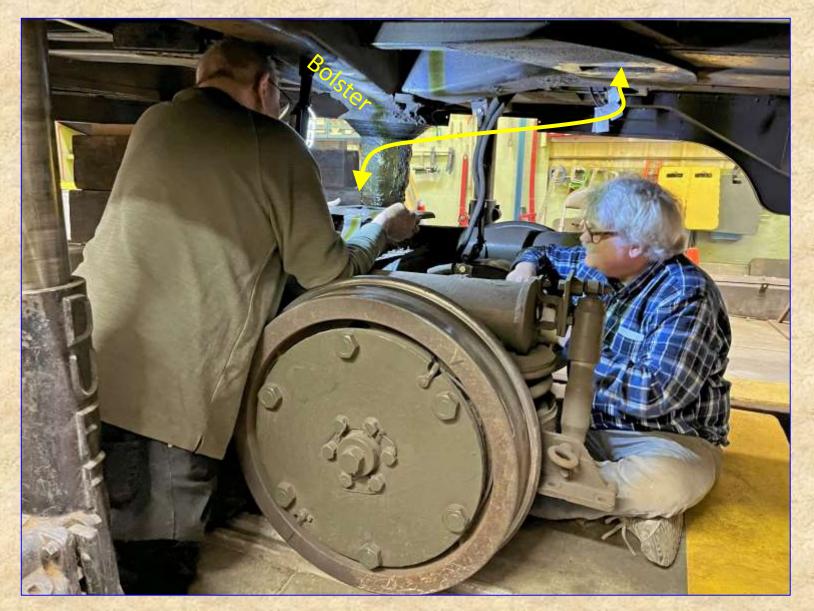
The jack is set under the bolster, inboard of the sill. A section of skirt has been removed to permit access. Jim Willmore and John Prestholdt are on the gate side here; Mark Digre is working the pole side lift. Unlike hydraulic jacks, it is not possible for a screw jack like this to collapse under sustained load.

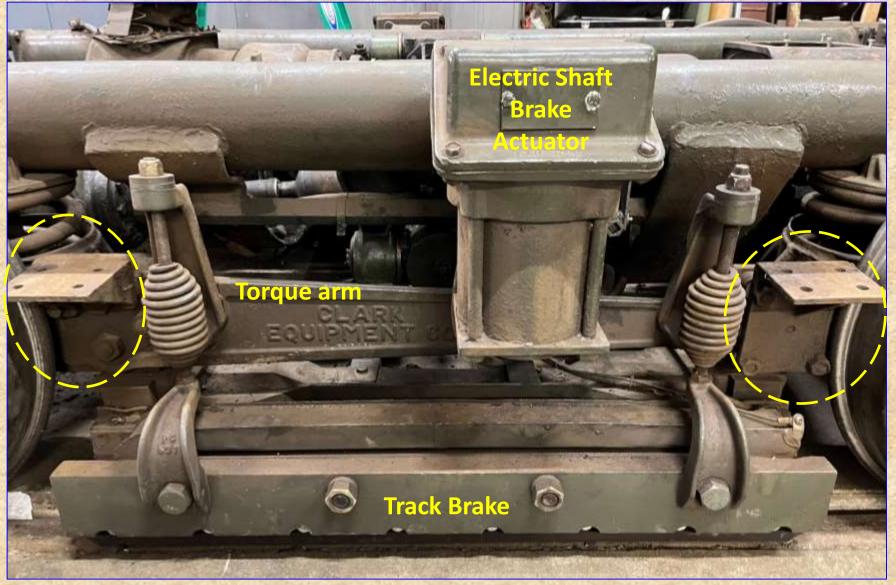
Rear truck / gate side is undamaged and provides a useful model

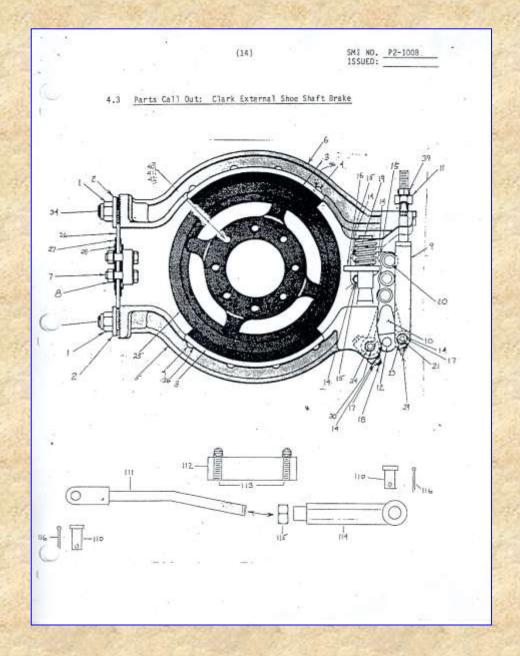
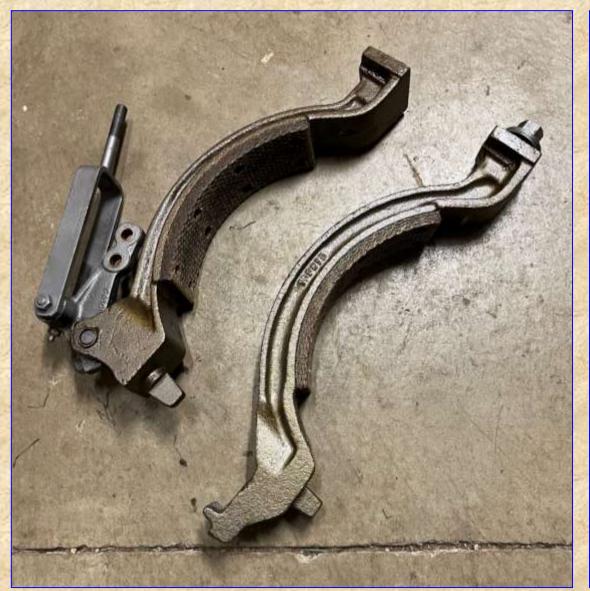
Only one pair of shaft brake shoes was badly worn; they have been relined locally.

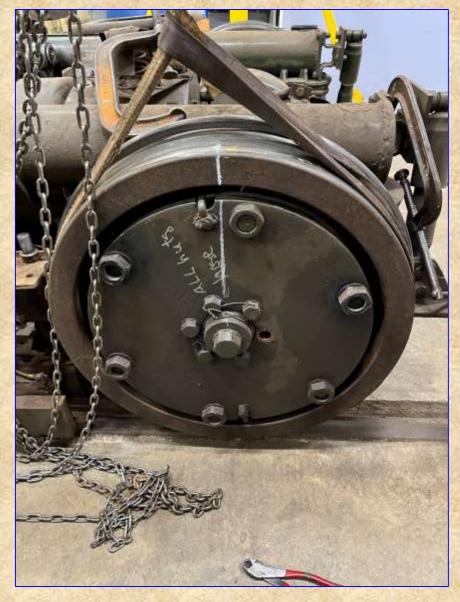
Wheel supported by sling after nuts and bolts are loosened; note the index line

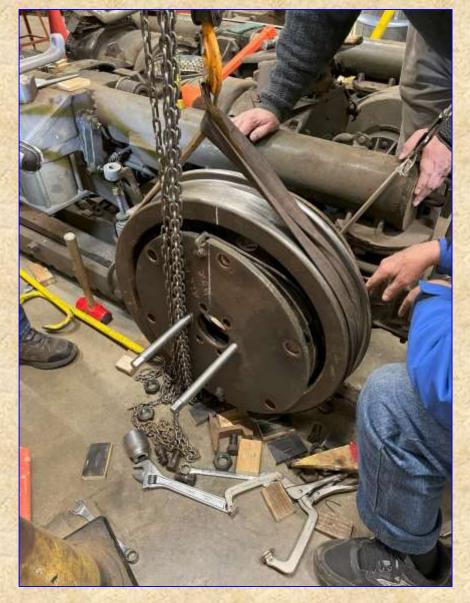
7/8"-14 UNF threaded guide rods maintain wheel component registry
