Streetcar CURRENTS

SPECIAL PHOTO SUPPLEMENT

NOVEMBER - 2010

YOUR DONATIONS ARE HARD AT WORK - PART 1

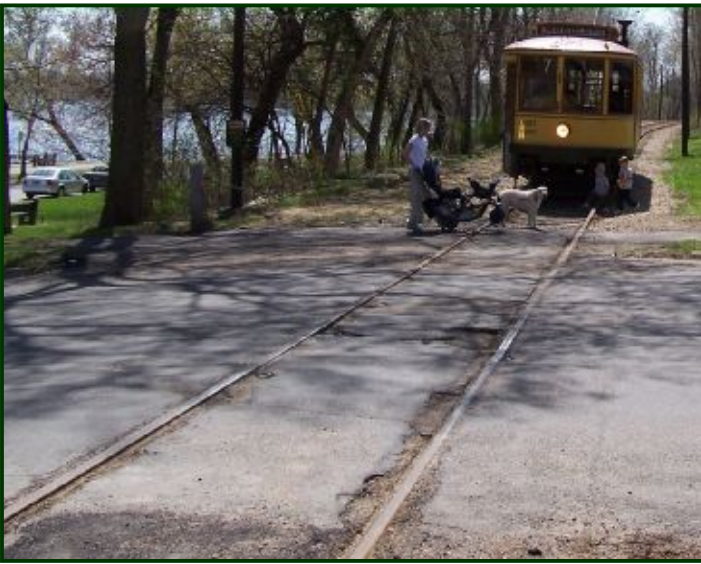
(Top Left) This is what the West 42nd Street crossing looked before the work started. The crossing was built in 1971 and was in obvious need of replacement. Besides the deteriorated ties and bad rail joints, the pavement also was in pretty bad shape as this photo attests.

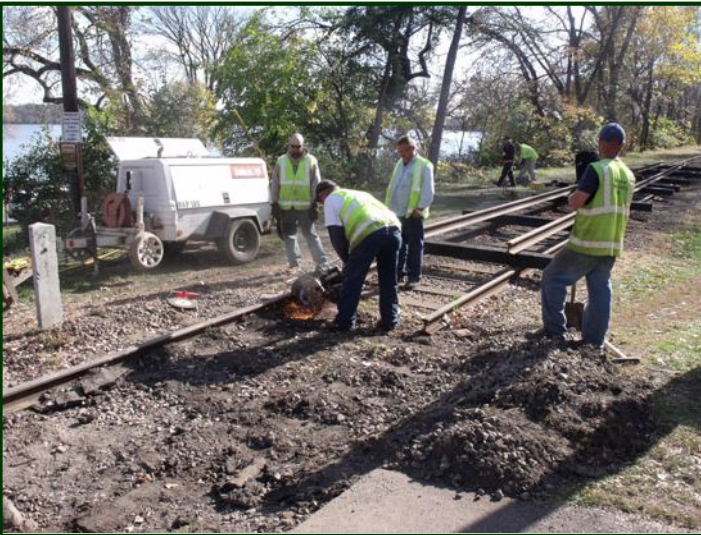
(Bottom Left) One of the Rail Specialties workers is using a rail saw to cut one of the old rails. The saw has a gasoline engine similar to a chain saw. To the rear are the two lengths of rails that were welded together using the Thermit process.

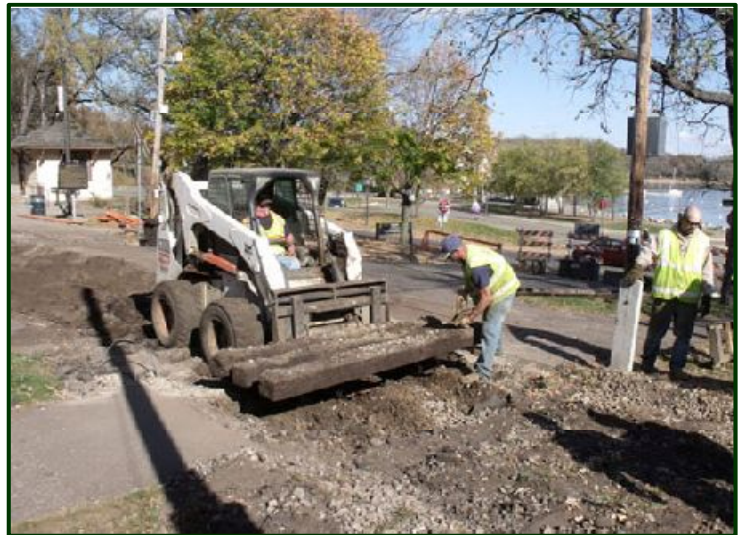
(Bottom Right) This photo shows the Bobcat taking out the last of the old ties. Next the bucket will replace the forks on the Bobcat, and the Bobcat will start removing the remaining fouled ballast and dirt in preparation for placing the new ties, trap rock ballast stone and rail.

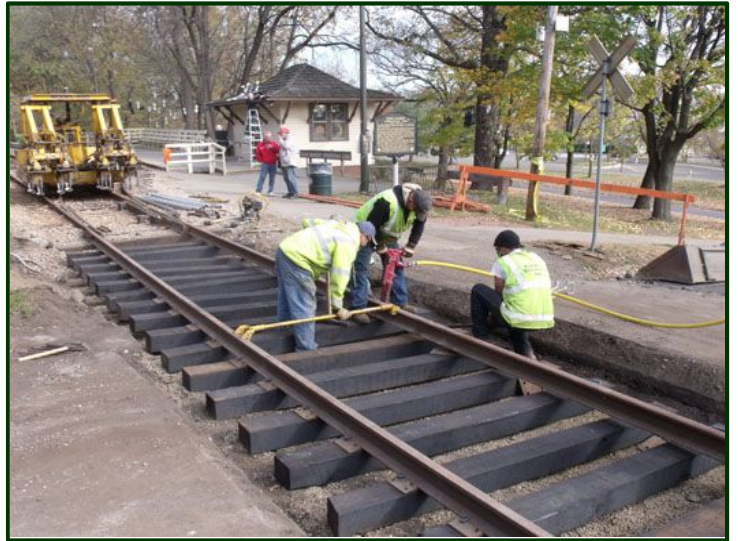
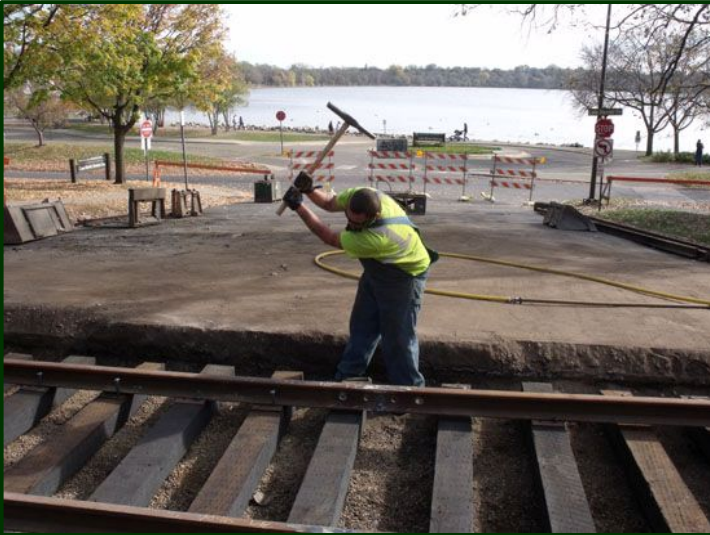
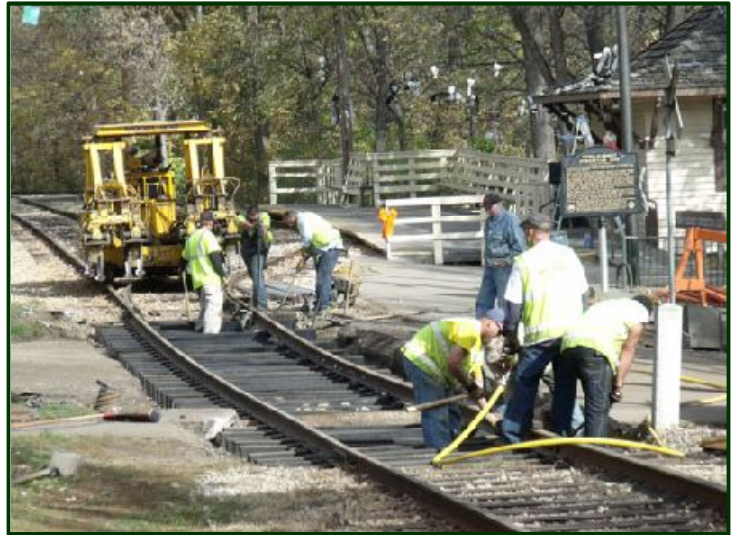
(Top Left) By the time your photographer arrived on the scene on October 19th, the trench was cleaned out, the new ties were put in and the two pieces of welded rail were placed on the ties and tie plates. Note the pile of trap rock ballast stone on the right.
(Top Right) Spiking the track to gauge has now begun. The implement in red is a pneumatic spike driver.
(Bottom Left) Some things still have to be done the old fashioned way. Note the welded joint opposite the Rail Specialties worker.
(Bottom Right) Two crews are working at each end of the crossing. The trackwork was finished in two days. In the rear is the tie tamping machine that will raise and level the new track. The City of Minneapolis was responsible for the asphalt work which happened the day after.
