Streetcar CURRENTS

SPECIAL PHOTO SUPPLEMENT

WINONA No. 10 RESTORATION UPDATE

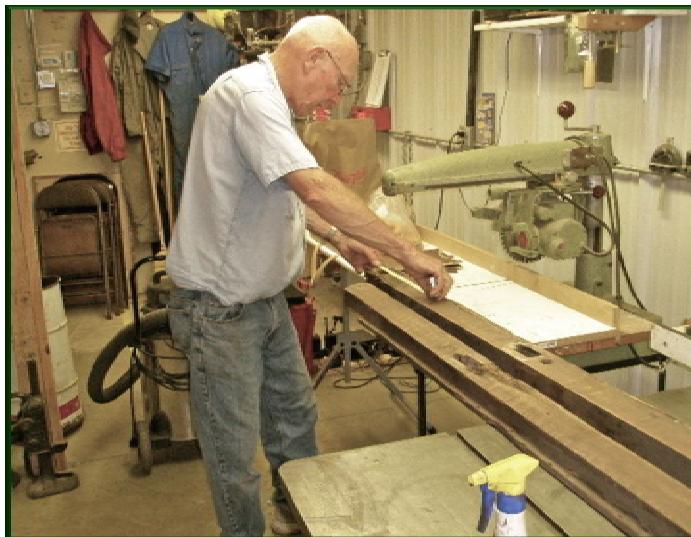
(Above) Here's Winona No. 10 Restoration Chief, **Ken Albrecht** working on one of the wood pieces of Winona No. 10. This was taken at the Museum's Excelsior carbarn and shop and shows Ken measuring one of the replica wood pieces that was fabricated based on the original piece of wood that was damaged structurally. (Photo by Bob Johnson)

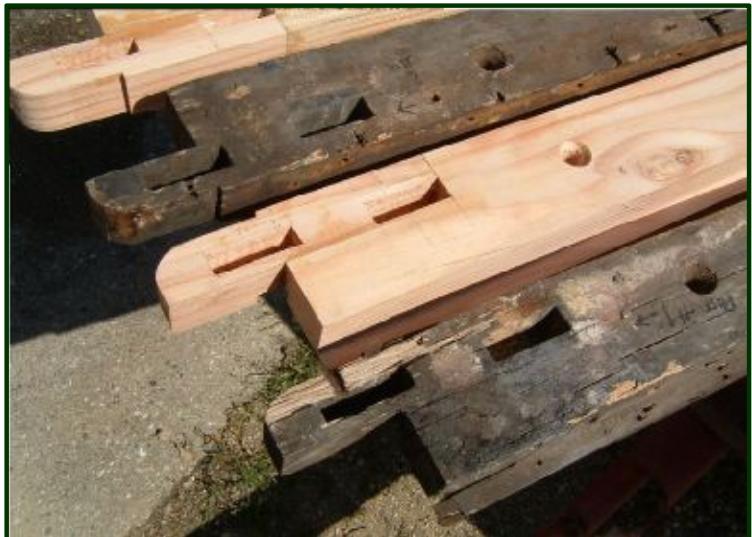
(Above) This photo shows some of the wood pieces that make up the substructure of Winona No. 10. In both instances the pieces were either broken (as you can see in the foreground) or suffered dry-rot damage making the piece, or a portion of the piece, unusable. (Photo by Ken Albrecht)

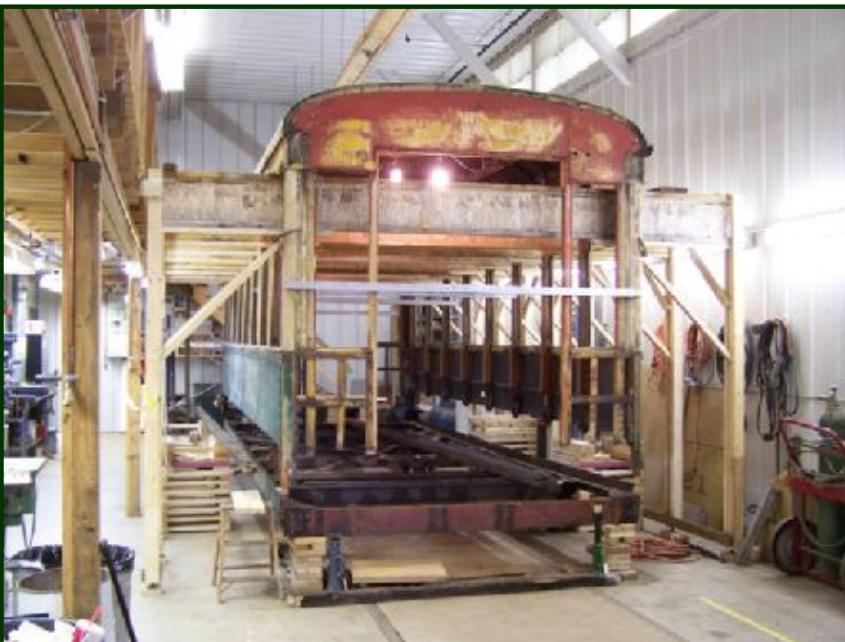
(Left) No. 10 has been in "suspended animation" now for several months giving the shop guys some time to assess the condition of the steel pieces that make up the underframe of the car. Actually, you really can't strip down No. 10 much more than it is right now. If you did any more dismantling all you'd have is a pile of lumber and some steel shapes. Our shop guys do amazing work! (*Jim Vaitkunas photo*)

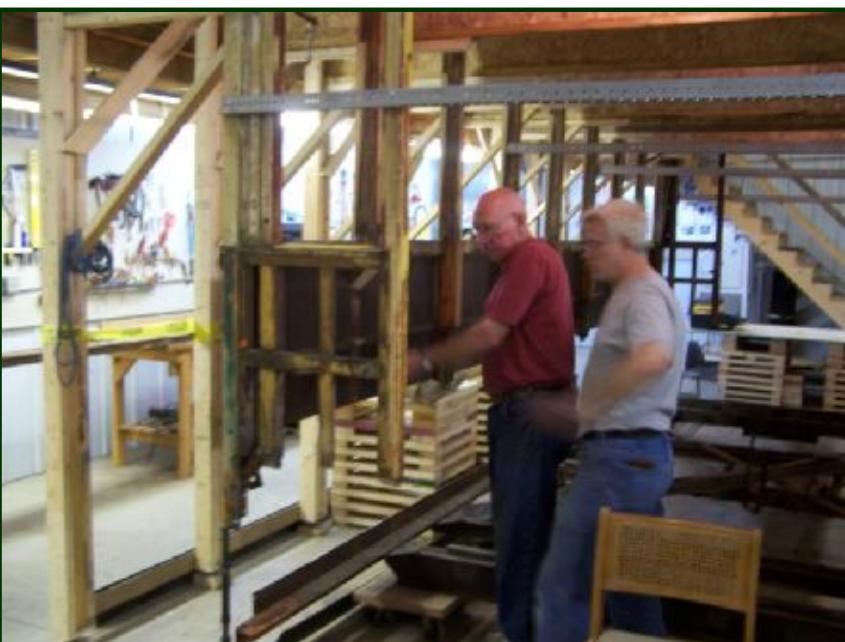
(Left) This photo shows **Ken Albrecht** on the left discussing a fine point with our master welder, **Howie Melco**. Howie will be the one to weld the bottom piece of the streetcar's steel side sheets back onto the car to make it whole again. This is an incredibly delicate job and, lucky for us, Howie is a master at it. (*Jim Vaitkunas photo*)

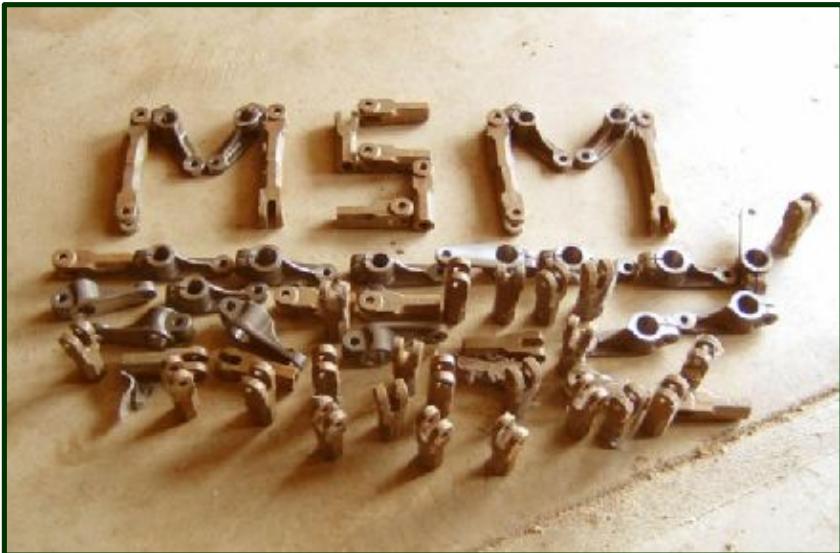
(Left) Here are just a few of the more than 250 pieces that will go into six individual door operating mechanisms on Winona No. 10. Winona No. 10 had manually operated doors on each side of each end when it was fabricated in 1914. Shortly after the cars were delivered two of the doors were sealed shut because the cars were never used as a two-man car, thus eliminating the need for a rear entry or exit door. Passengers boarded and alighted from the car at the front opposite the Motorman. The Motorman controlled the two sets of doors to his right using short levers on vertical shafts that are connected to a bewildering array of rods, cranks, and other "knick-knacks" located under each platform. (Ken Albrecht photo)

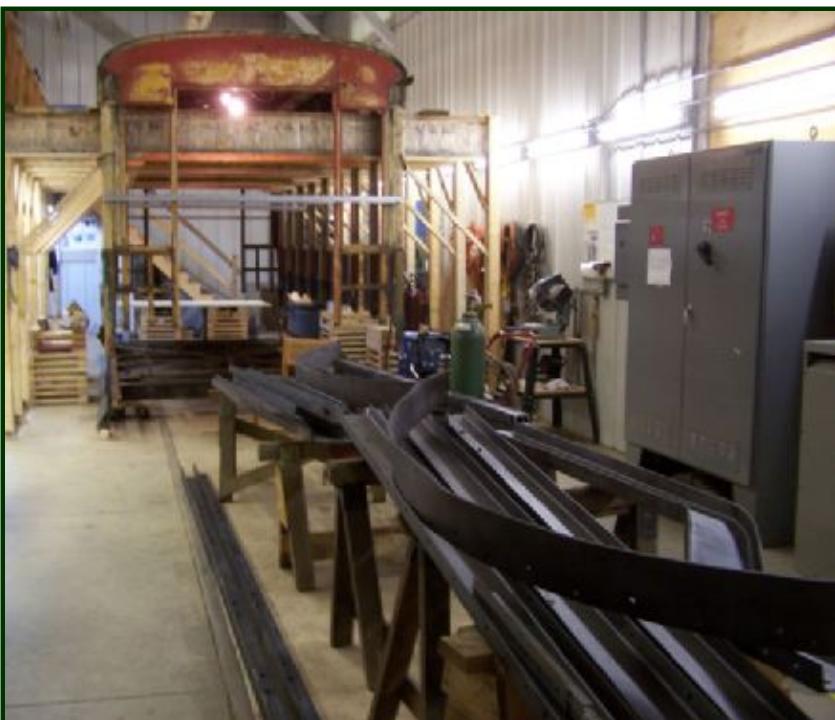
(Left) Here's a general view of Winona No. 10 in the restoration shop. Those dark pieces in the foreground are the individual pieces that made up the platform support. They have been cleaned and sand blasted so the restoration guys can determine whether they can be re-used on the car. Some of the pieces have corroded beyond use while others are just fine and will be put back onto the car to reduce the expense of the restoration. All pieces are marked so they'll go back on the car exactly from where they were removed.

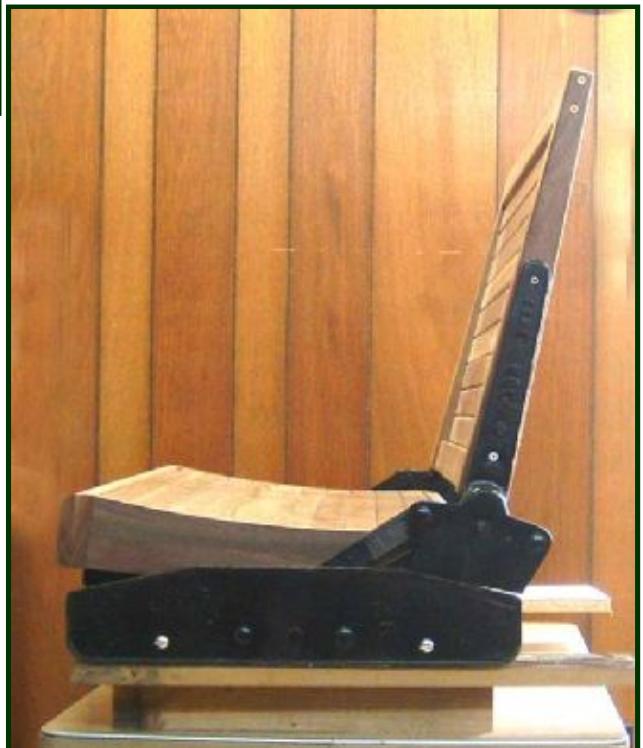
(Right) This photo shows one of the twelve "walk-over" or flip-over seats that will be installed in Winona No. 10. Since Winona No. 10 was a doubled-ended car, at the end of the line the seats had to be reversed so that passengers would always face towards the front of the car. This will also be the case at our Como-Harriet Streetcar Line and No. 10 be an entirely new experience for our passengers and crew because the seats will have to be flipped over twice for each run—once at the Lake Calhoun end and then again at the George Isaacs carbarn end of our Como-Harriet line. (Ken Albrecht photo)
