# Streetcar CURRENTS

## SPECIAL PHOTO SUPPLEMENT AUGUST - 2012

### WINONA NO. 10 RESTORATION PROGRESS

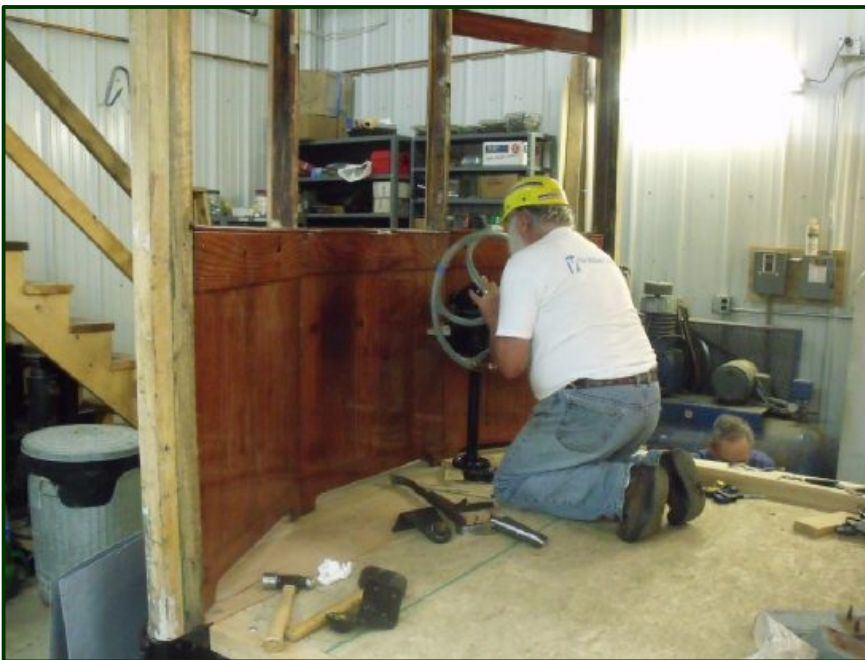
(Left) The crew is working on one platform at a time. Here we see **Steve Mages** taking measurements of one of the brake stands to make the brace that will connect it to the front of the streetcar. The refined wood panels shown in this photo are temporarily in place. They will be fixed in place once the outside front sheet metal dasher is installed and the headlight is in place and wired.

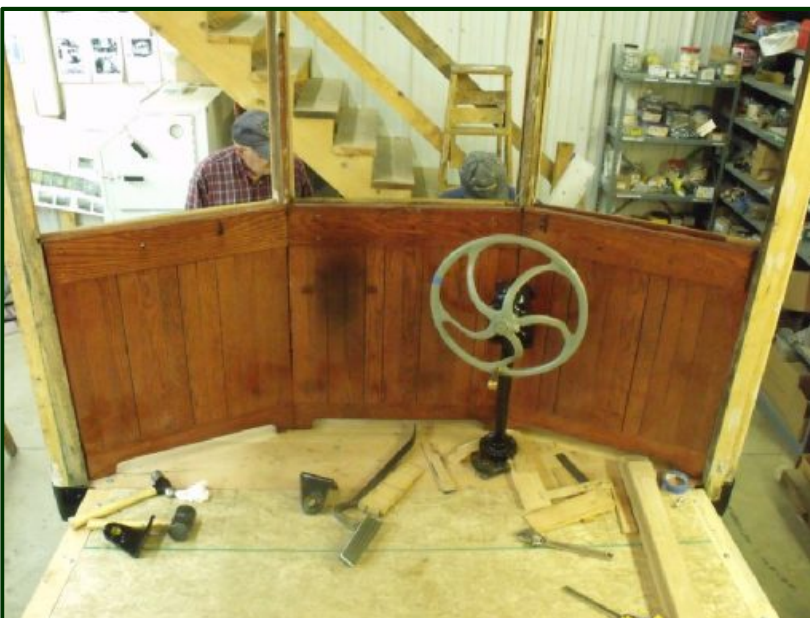
(Bottom Left) The platform floor you see in this photo is temporary. There is a lot of wiring, air brake pipes and hand-operated door rods and bell-cranks underneath the platform and it'll be easier to install these items if the permanent floor boards are not in place. Note the dark area to the left of the brake stand. This is where an electric heater was installed for the benefit and “comfort” of the operator.

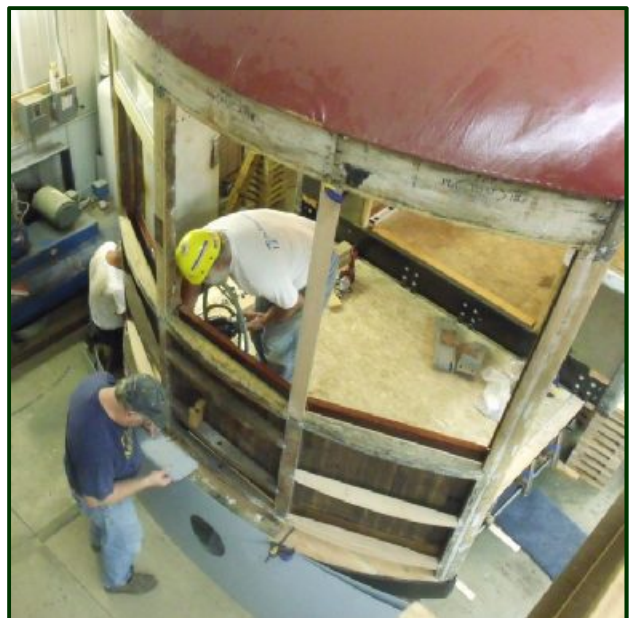
(Bottom) Here we see **Dick Zawacki** and **Steve Mages** working on the platform. **Tom McGruder** is partially hidden around the corner of the platform. The sheet metal dashers seen on the shop floor in front of Dick have been primed in grey paint and will be on the front of the streetcar soon. (*Jim Vaitkunas photos*)

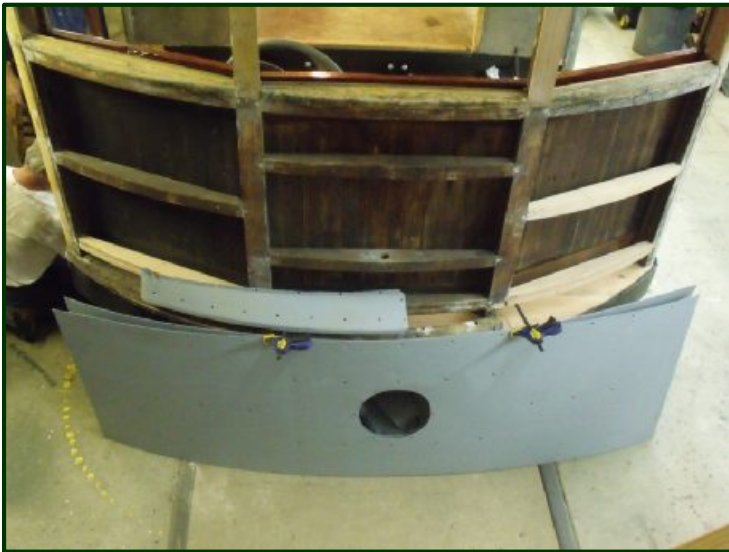
Here a close-up of the end of Winona No. 10. The metal dasher panels have been primed but are not yet ready to be installed. Note the obviously new pieces of wood. Some of the old wood pieces were rotten beyond re-use. (Jim Vaitkunas photo)

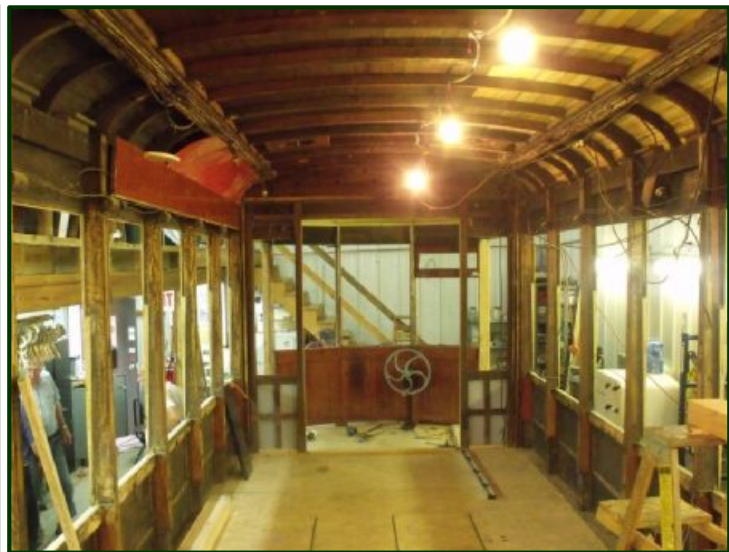
Here is the "bare bones" look of the streetcar at the moment. It looks like the guys have put up some of the interior shown on the upper left to see how things will fit. The floor is also temporary to allow for later under-floor work as mentioned above. (Jim Vaitkunas photo)

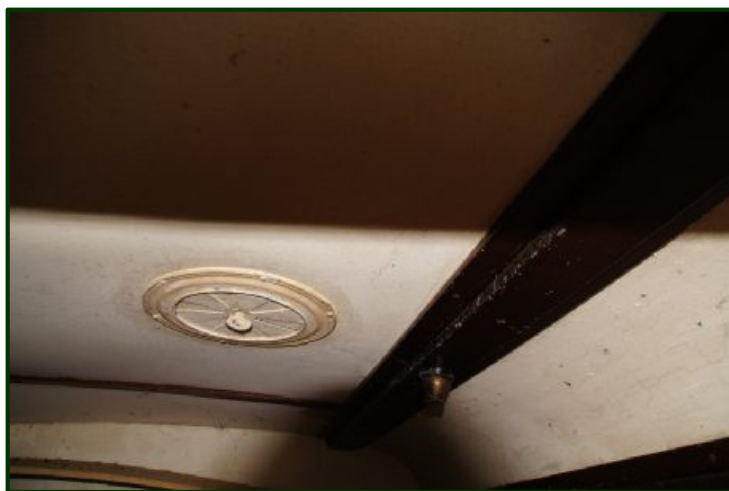
Finding No. 9 and then being allowed to visit to take measurements and remove some hardware items was a godsend to our restoration of No. 10. We had only one original ceiling vent and found all of them intact in No. 9. We also got some original interior light fixtures and window lift hardware. The ceiling on our No. 10 was long-gone when we got it and it was good to see the original ceiling still in No. 9 (Dick Zawacki photo)

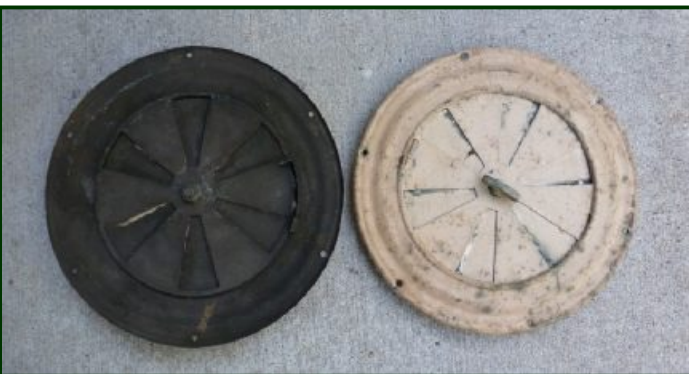
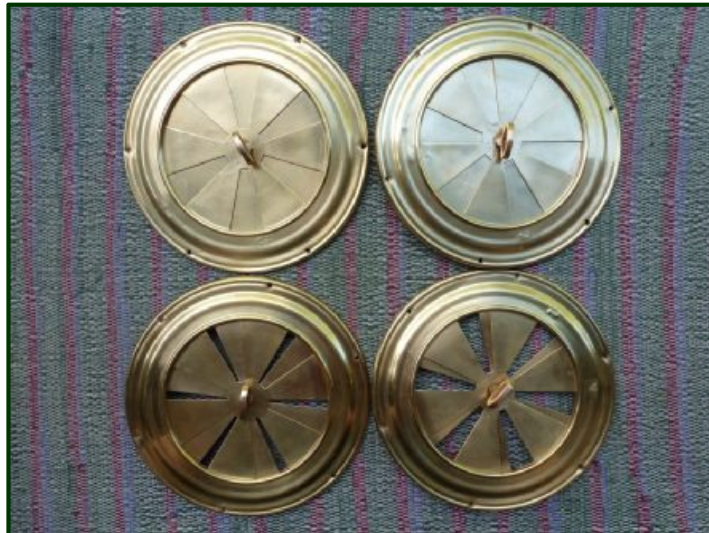
**Before and After**

The above photo shows two of the original brass ceiling vents that we were allowed to remove from No. 9. After some hard work and TLC on the part of **Dennis Stephens**, four of the refurbished vents are shown in the photo on the right. (Dennis Stephens photos)
