Streetcar CURRENTS

SPECIAL PHOTO SUPPLEMENT DECEMBER - 2013

PROGRESS ON THE RESTORATION OF WINONA NO. 10

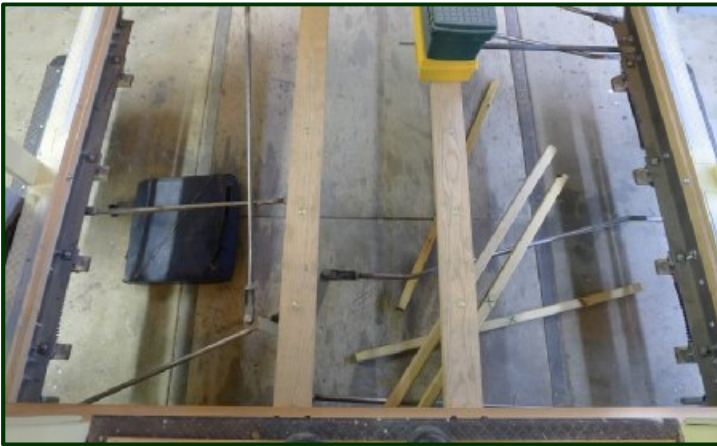
The steel rods you see are the linkages between the door control handles on the platform and the doors and steps. Winona No. 10 was a no frills streetcar—when delivered in 1914, nothing in the car was operated by air or electric motors other than the traction motors. Doors were hand operated. In fact when the car was first operated in Winona in 1914, the car didn't have air brakes, just hand brakes! Air brakes were installed within a year or so, however, as the car was too heavy for hand brakes.

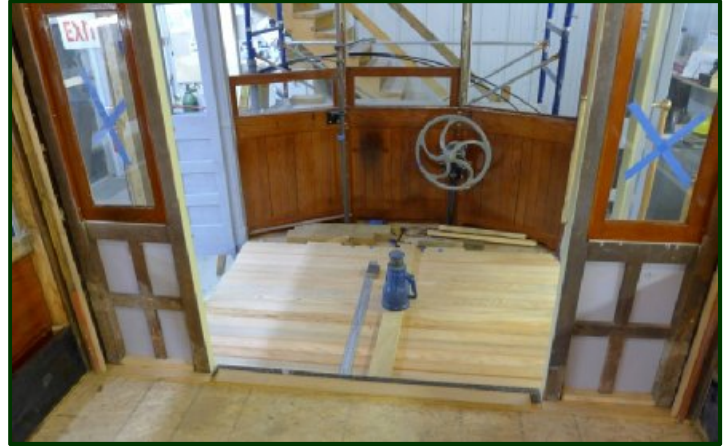
The platform floor is now being installed. The shaft seen in front of the left window post controls the two doors on the right. The doors on the left were not controlled from inside the streetcar and actually one of them was permanently fixed closed when the car was new. Within a short time both doors opposite the regular entry/exit doors to the right of the Motorman were permanently closed.

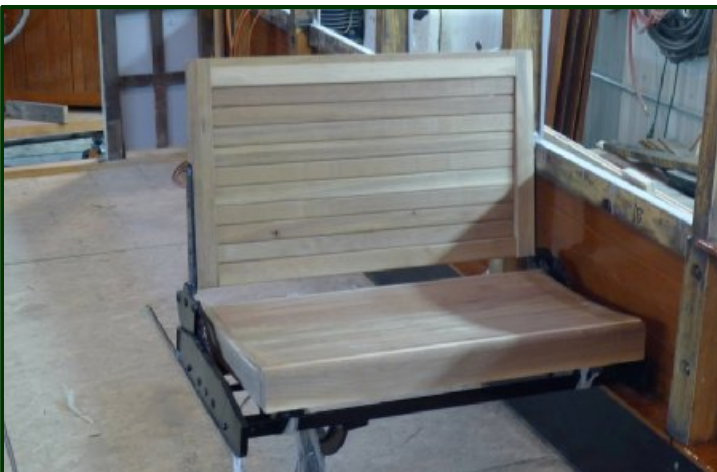
One of the walkover (flip over) seats was placed temporarily in the car just to see how it fits. The seat still needs stain and varnish.

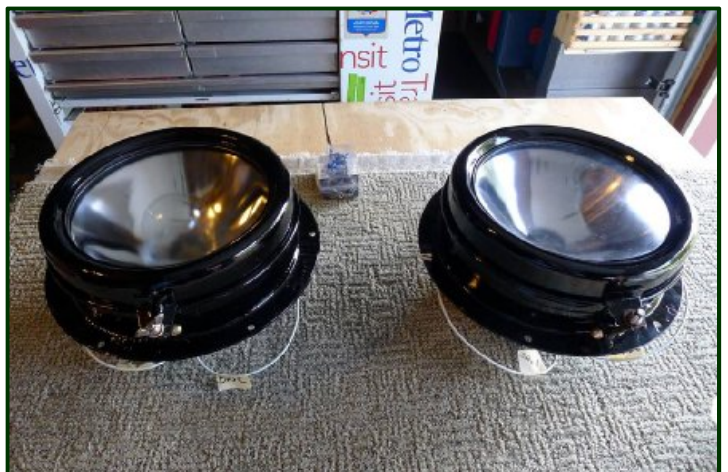
Howie Melco completely refurbished and repainted Winona No. 10's two headlights.

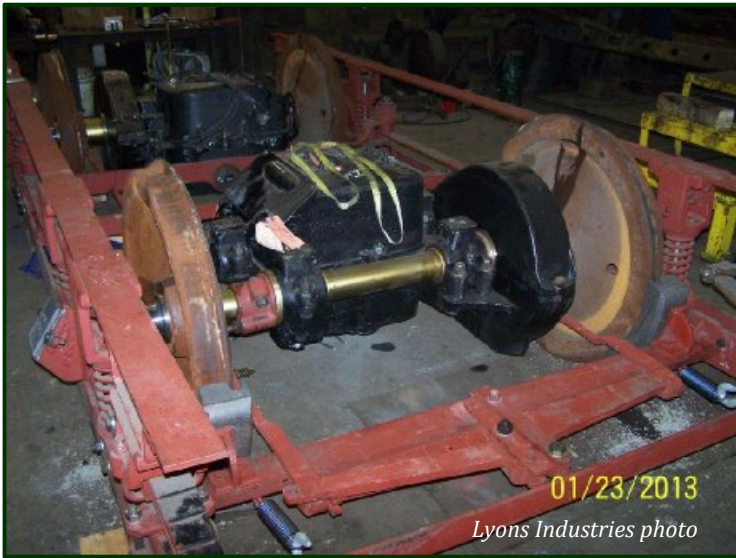
Winona No. 10's truck has been worked on for over a year. Here's a photo taken in January 2013 showing the progress made up to that point. In January we needed to find a small air compressor. We found one and it has now been mounted on the truck.

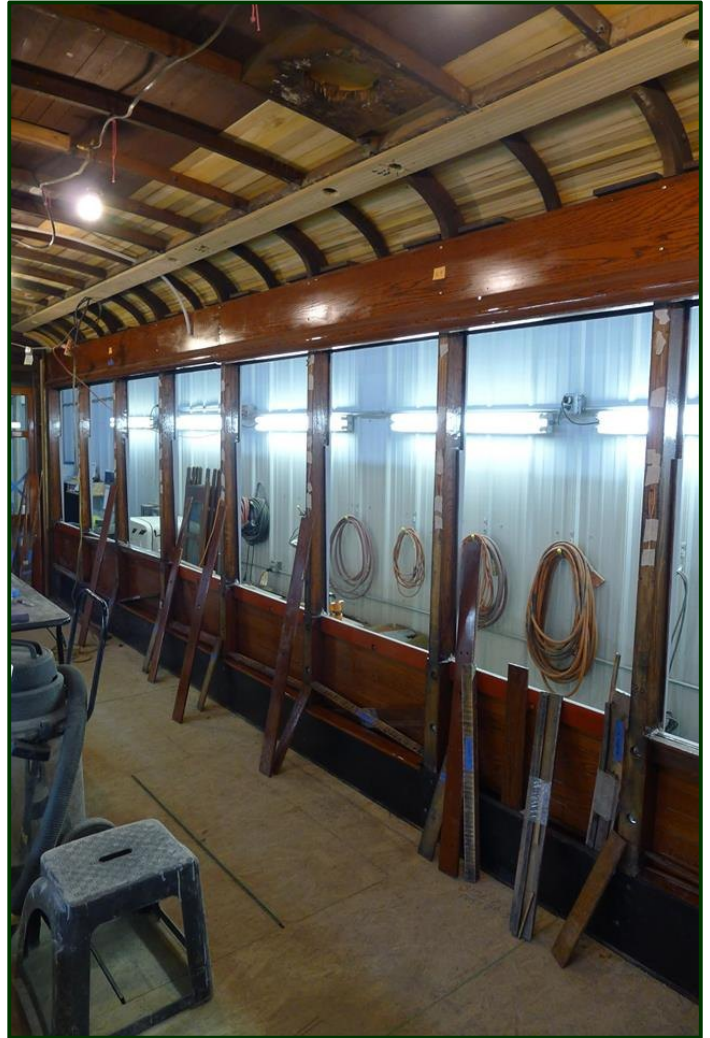
Finished woodwork and trim are being put back on No. 10. The plywood floor you see is temporary. Also note the new roof boards.

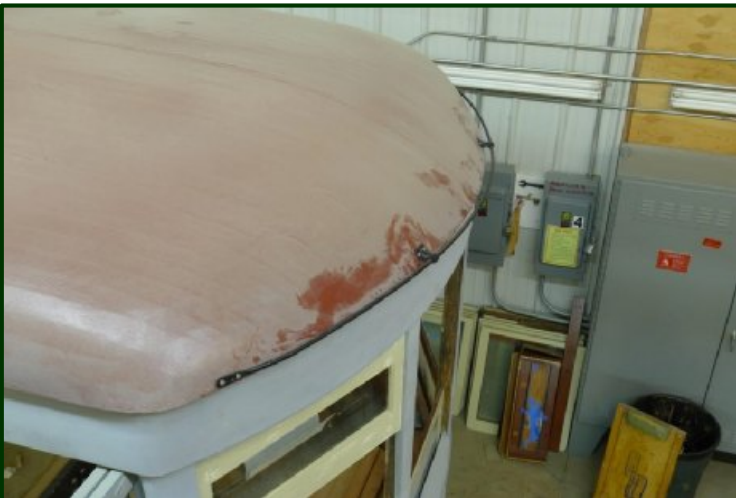
Major and minor hardware are gradually being put back on Winona No. 10. Here we see the rub rail has just been put on the front of the platform roof. This piece prevents the trolley rope from rubbing the edge of the roof and wearing away the paint and canvas roof material.

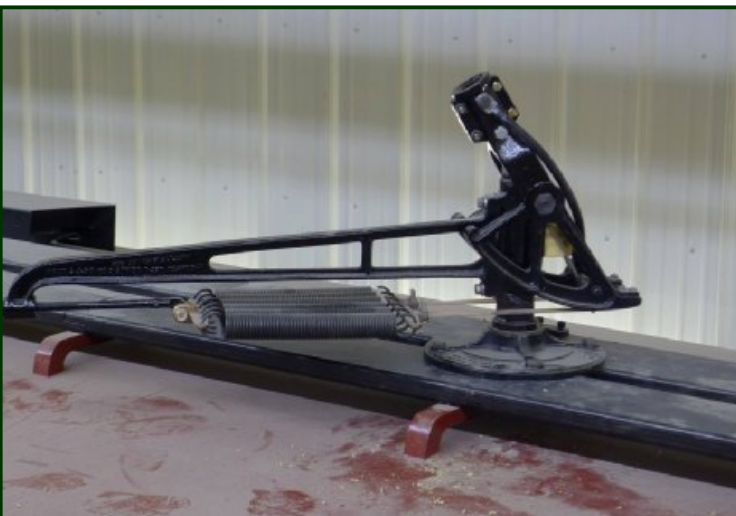
Here's the trolley pole base just installed on the roof's trolley boards. This photo was taken a few hours after the photo on the right. **Dennis Stephens** worked on rebuilding the trolley base.

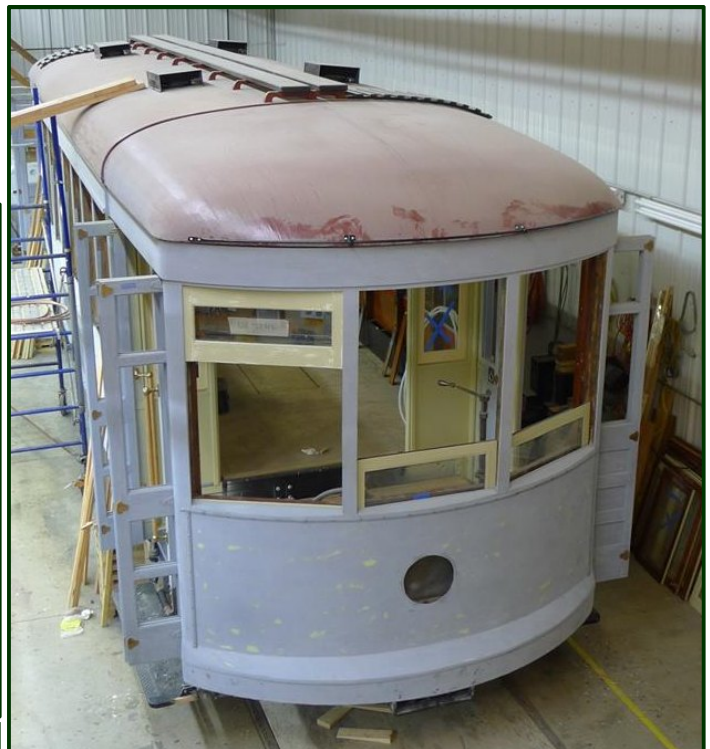
Roof appurtenances and route/destination sign box are installed.
