Torque Arm function and description

Wheel Re-installation, forward truck

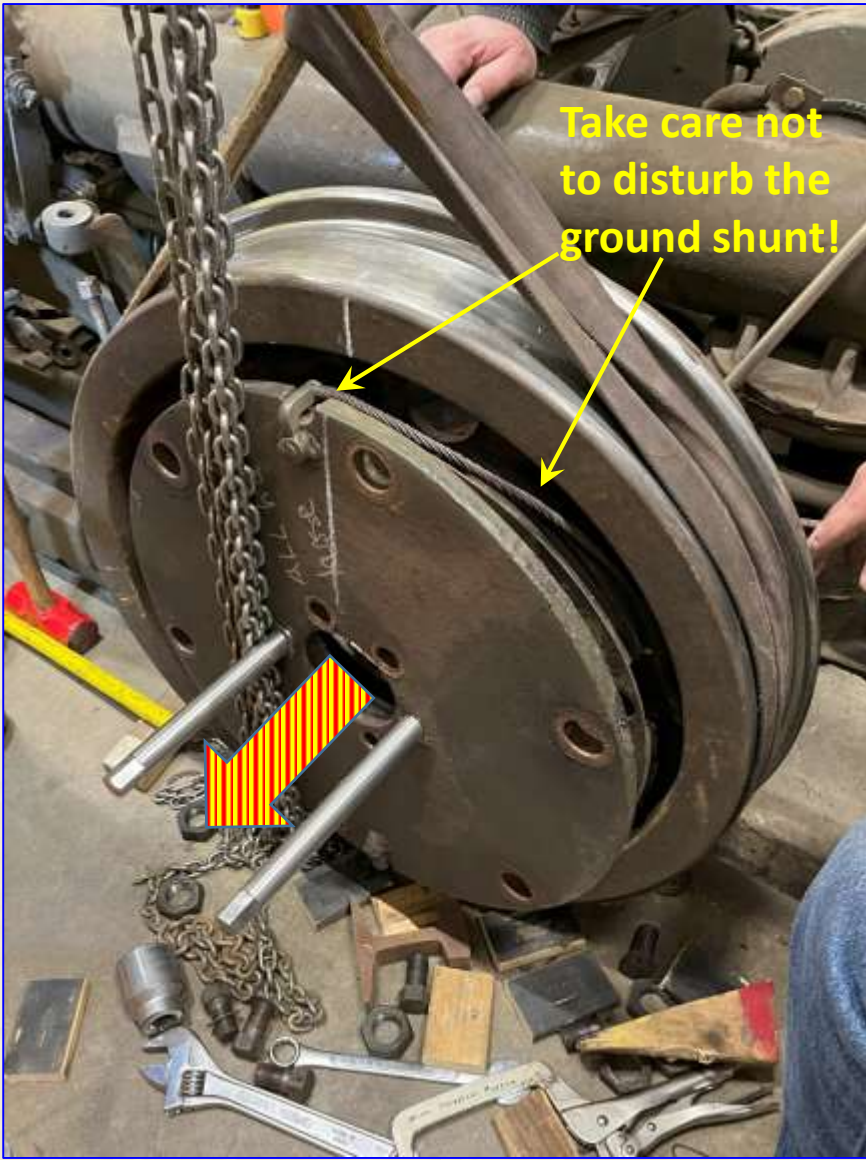
Much prying and hoist adjustment moved the assembly despite guide rods binding.

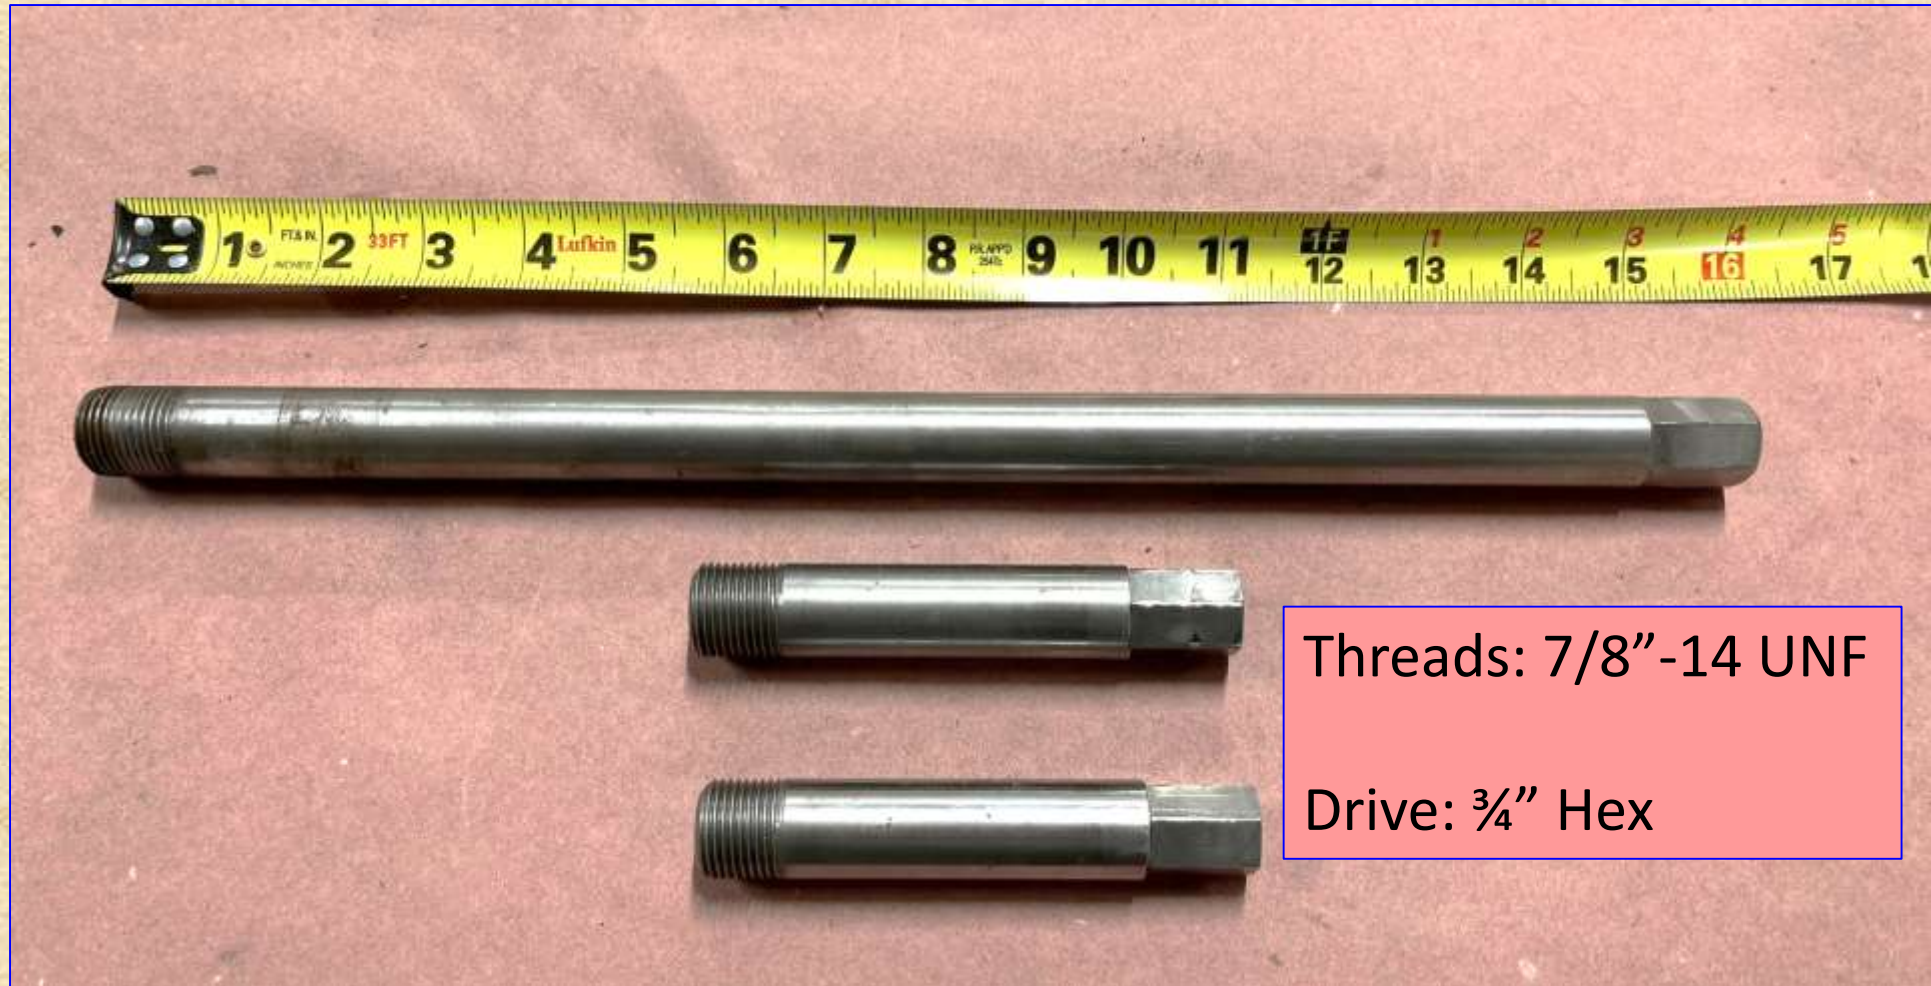
Long guide rods caused binding; they were shortened from 16" to 5" OAL

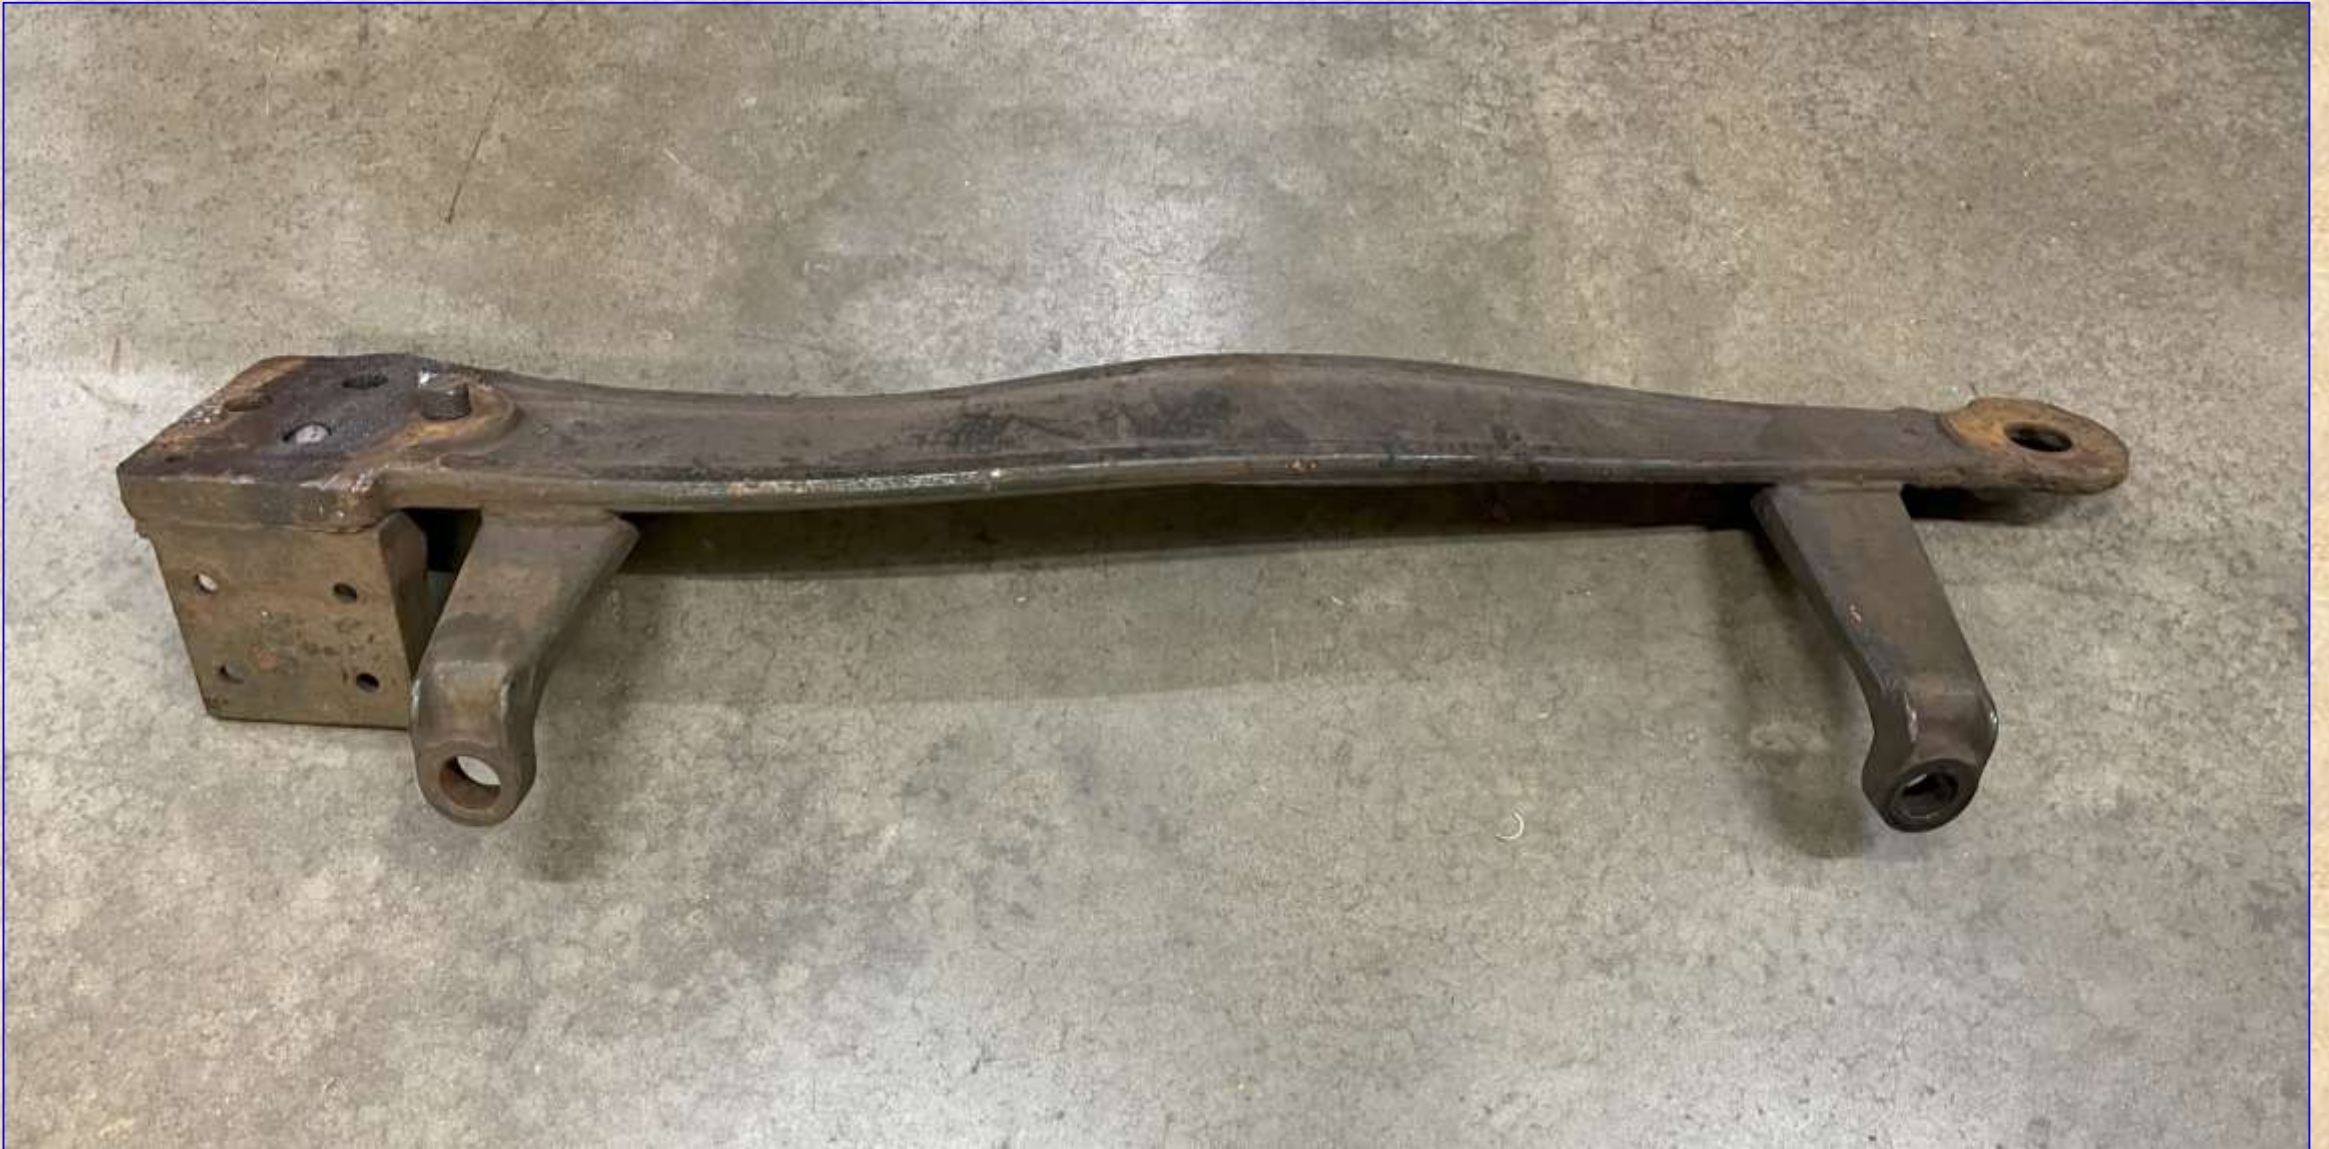
Severely deformed torque arm, rear truck, pole side. See also slide #3.

This torque arm may be salvageable but it is bent in both planes.

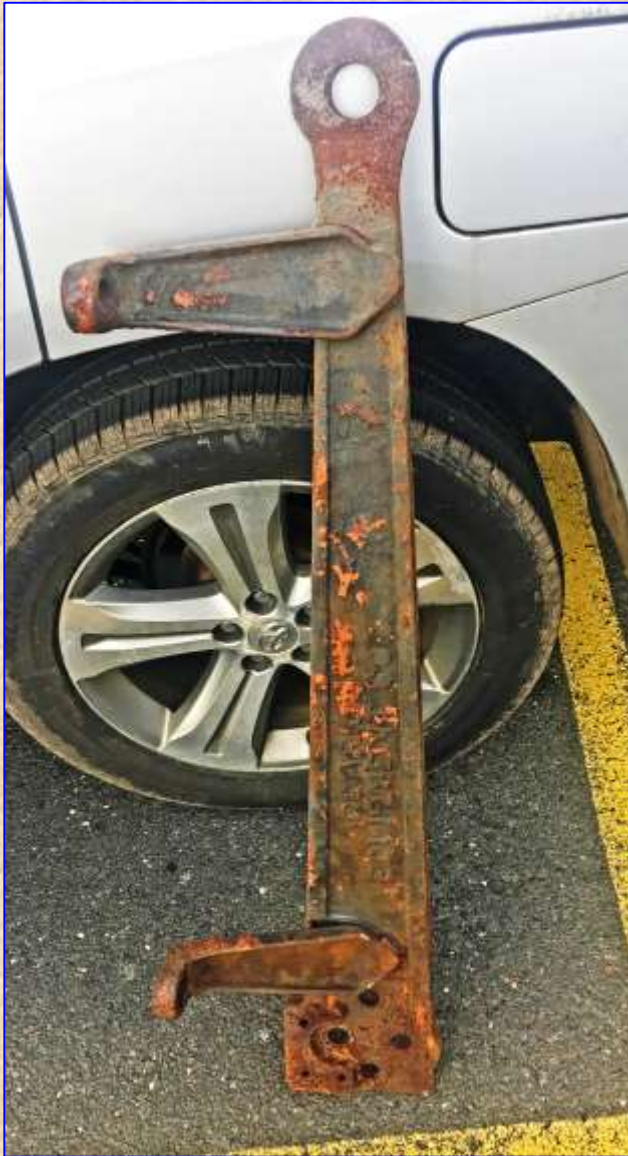
As-salvaged

Salvaged Clark Torque Arms, procured through Bill Wall at Shore Line Trolley Museum

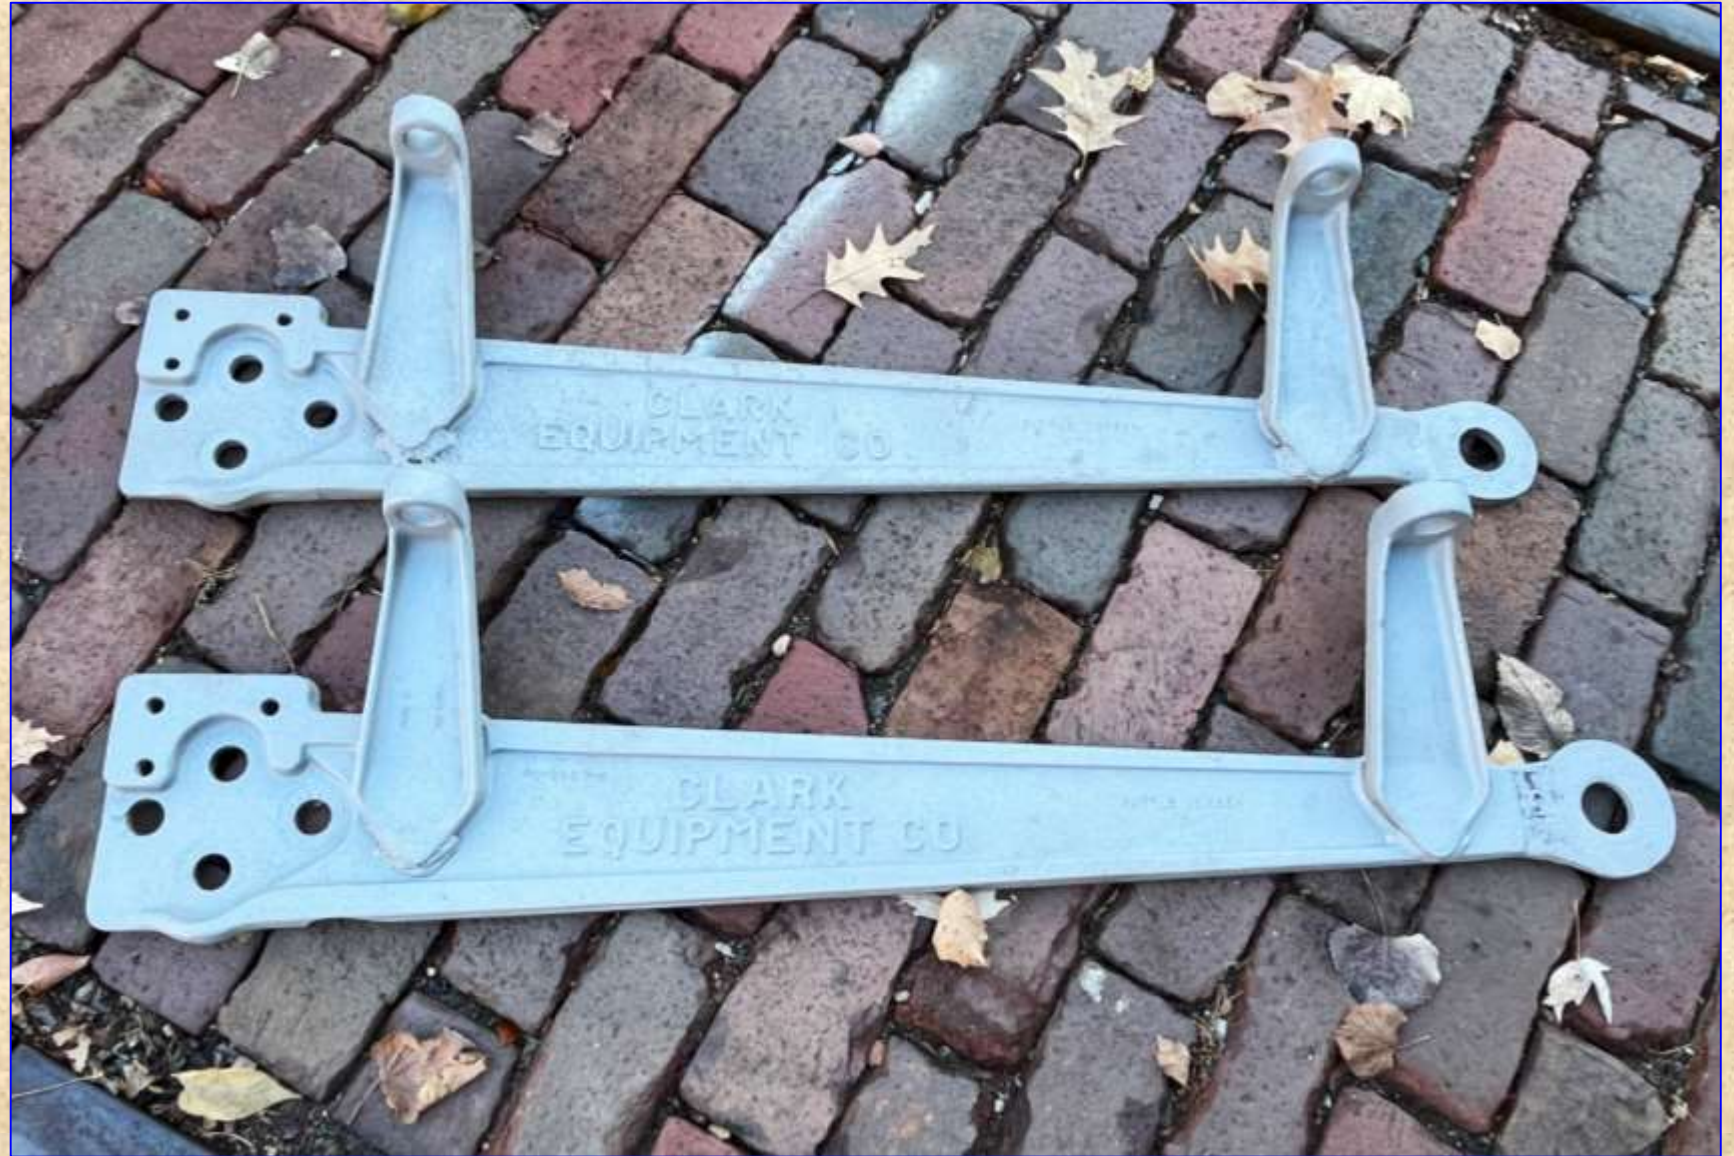
Cleaned by Brighton Sandblasting, Inc., Blaine, MN

The sandwich at left is badly corroded and the rubber is degraded.

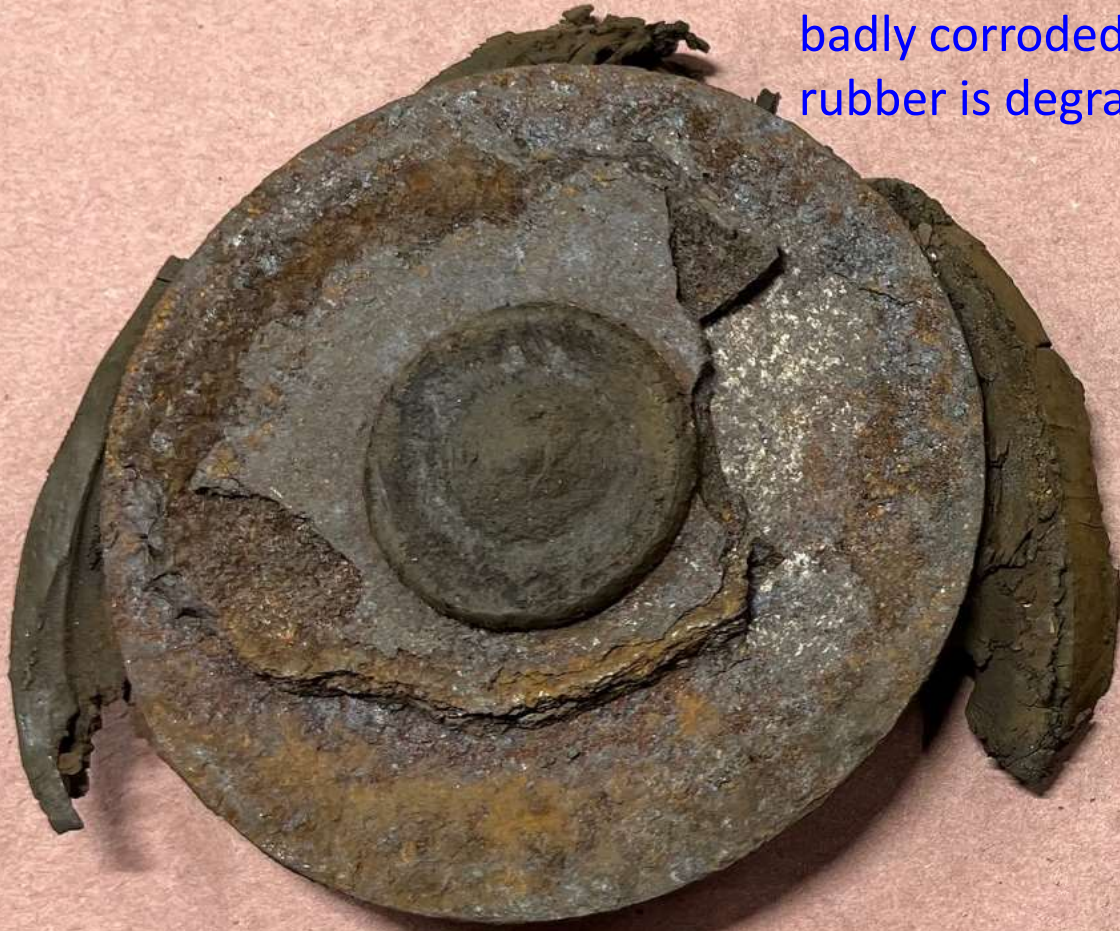
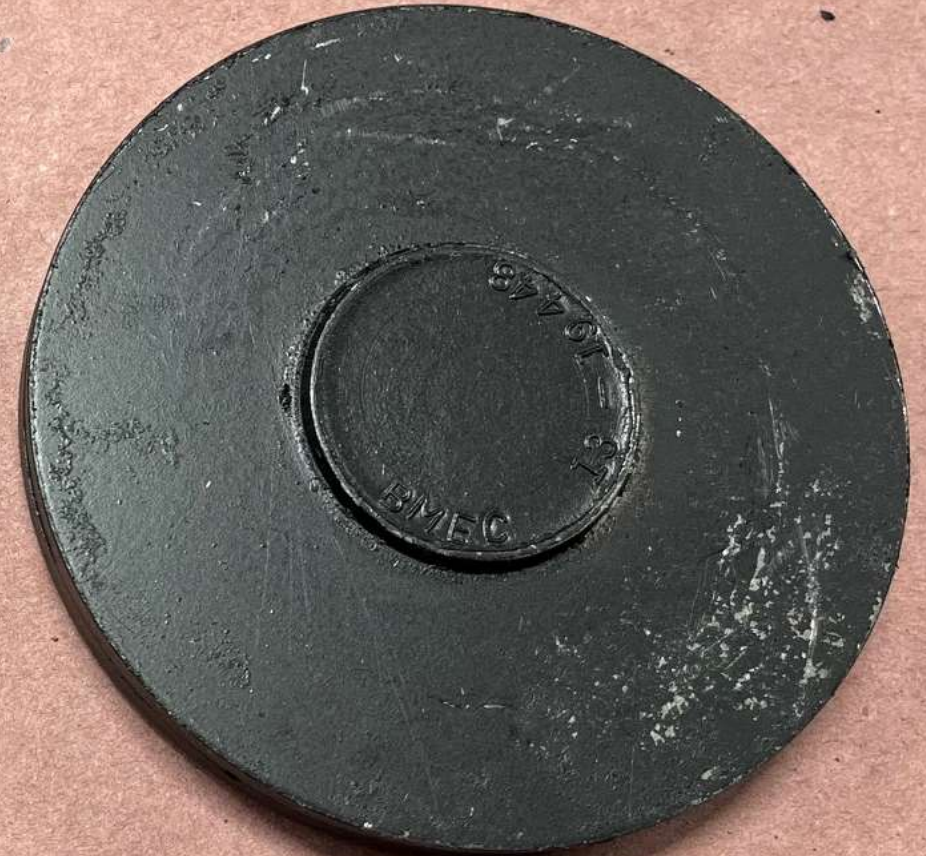
Torque Arm Sandwiches are used in pairs; see next slide.

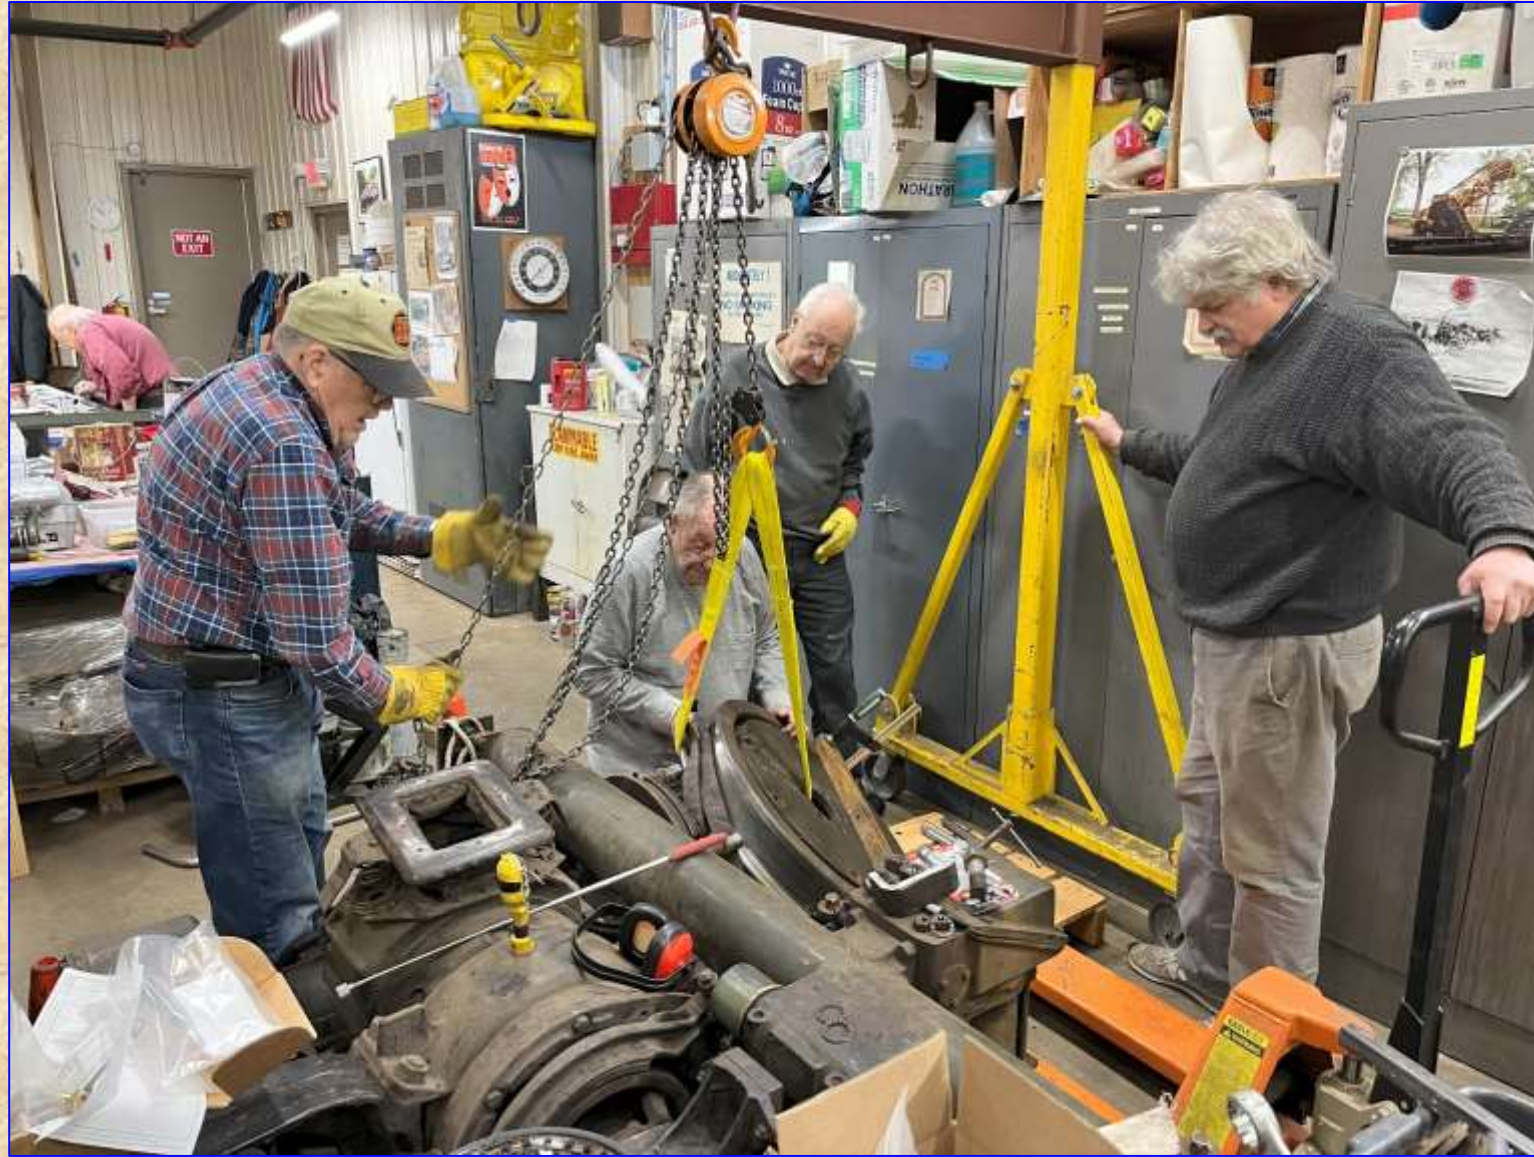
Wheel replacement with the aid of the gantry crane was cumbersome

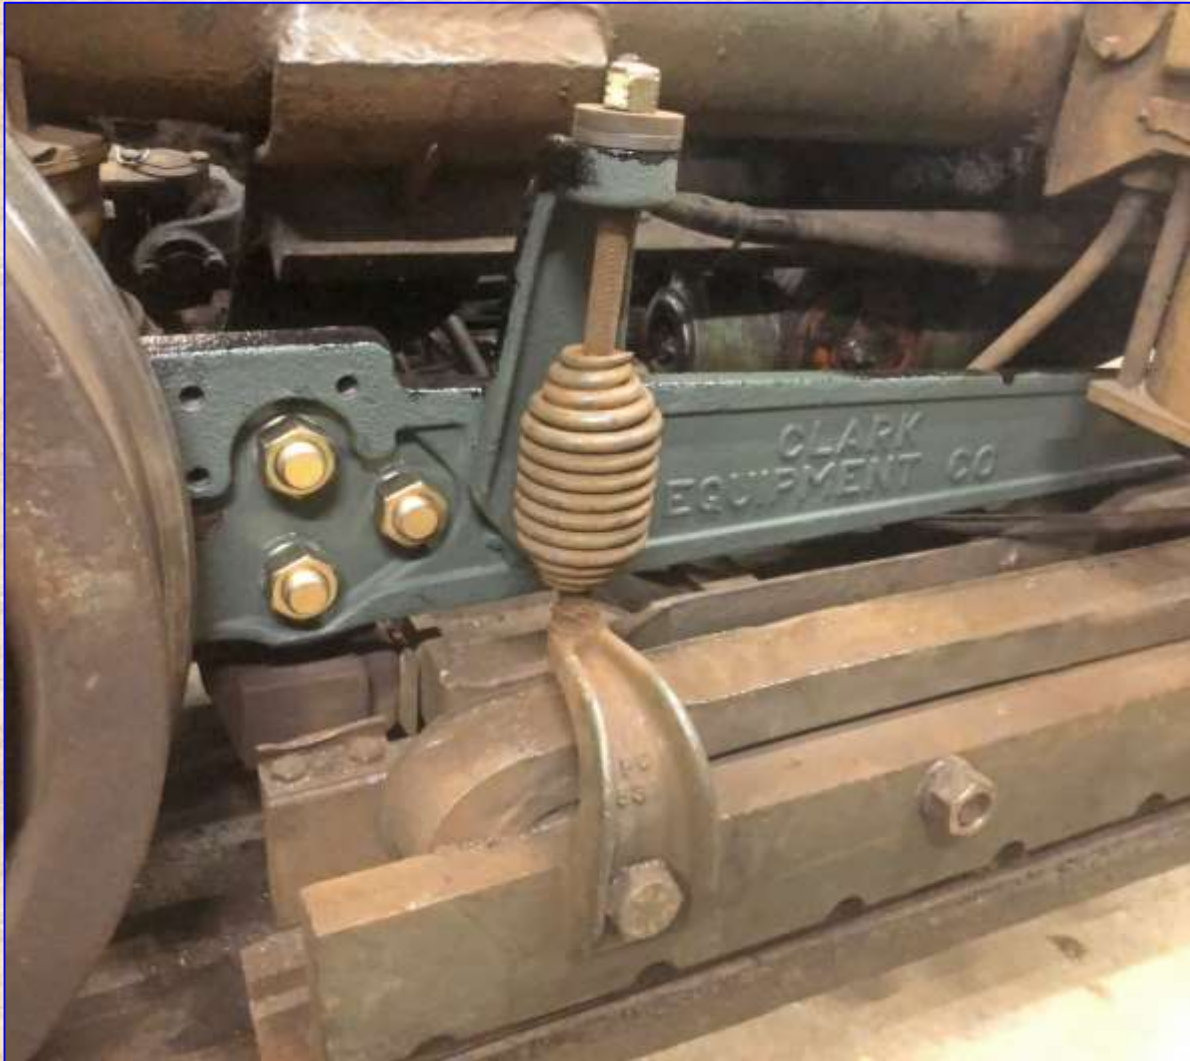
Replacement torque arm installed, rear truck, pole side (Russ Isbrandt photos)

Forward end; L-bracket (slide 16) discarded

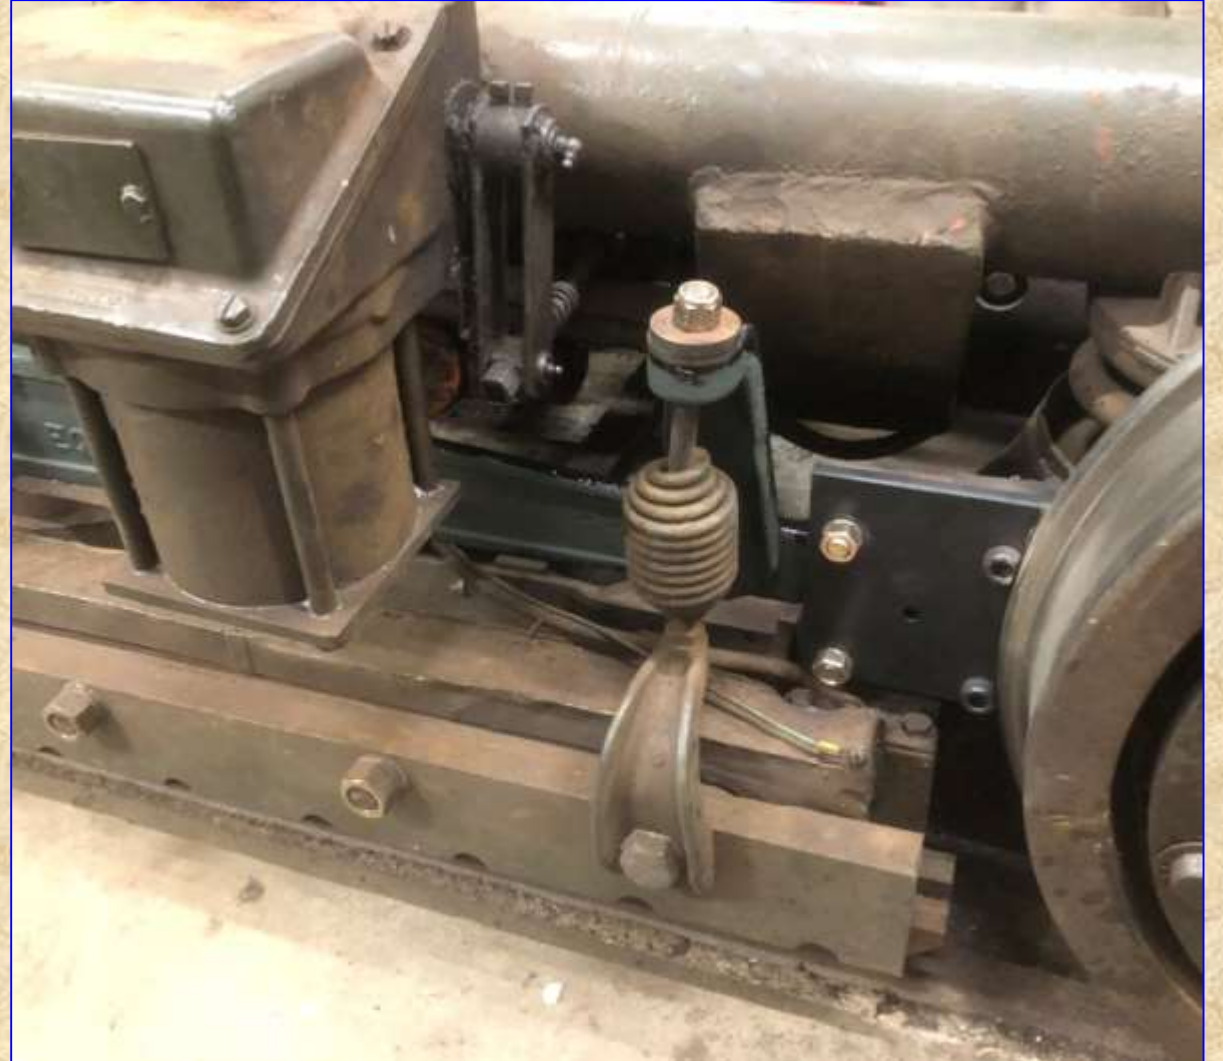
Aft end; L-bracket replaced by a simple plate

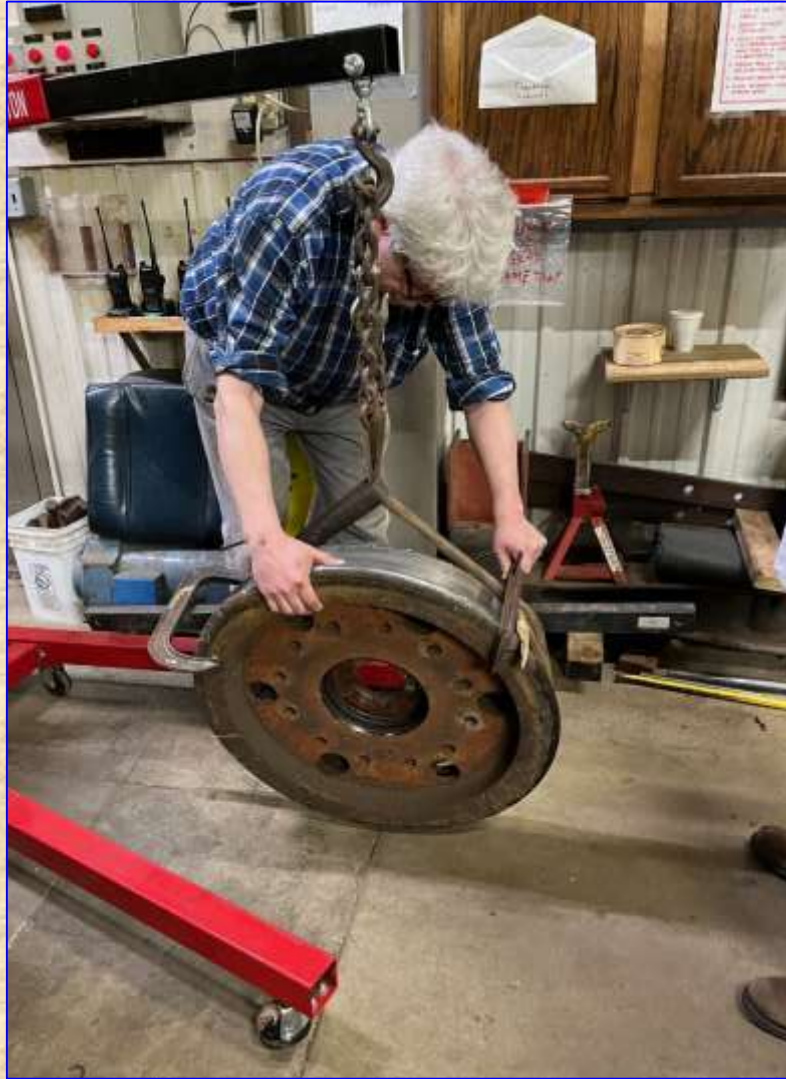
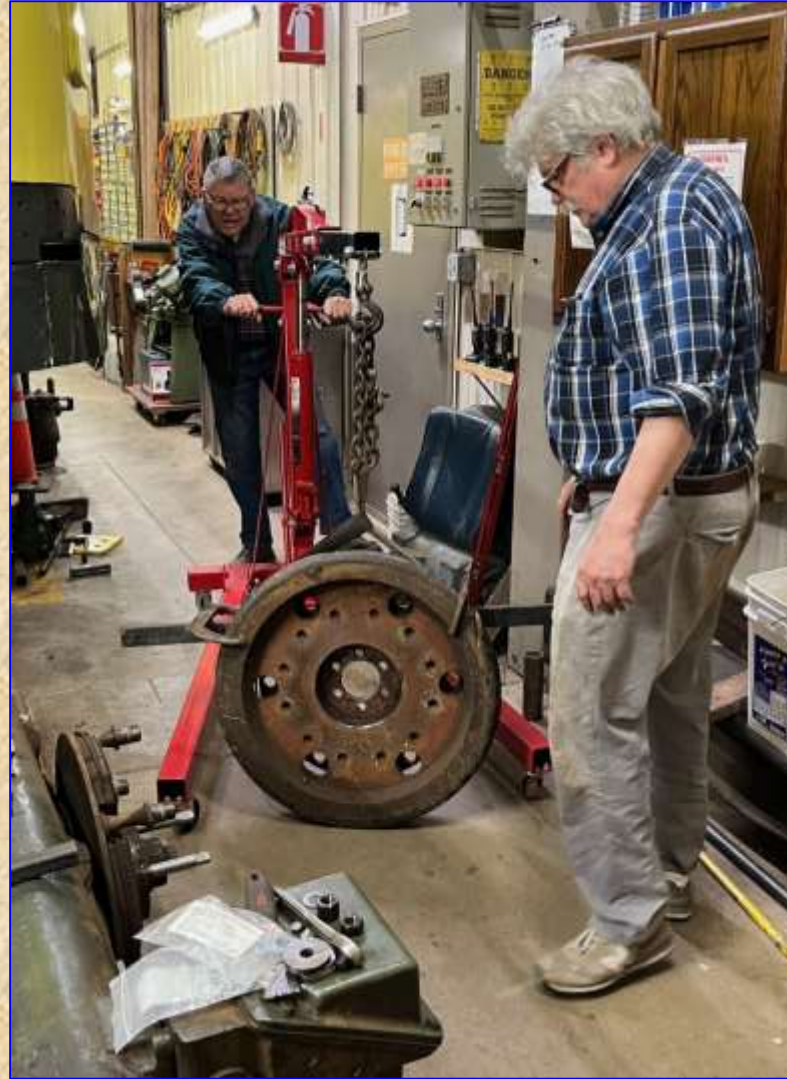
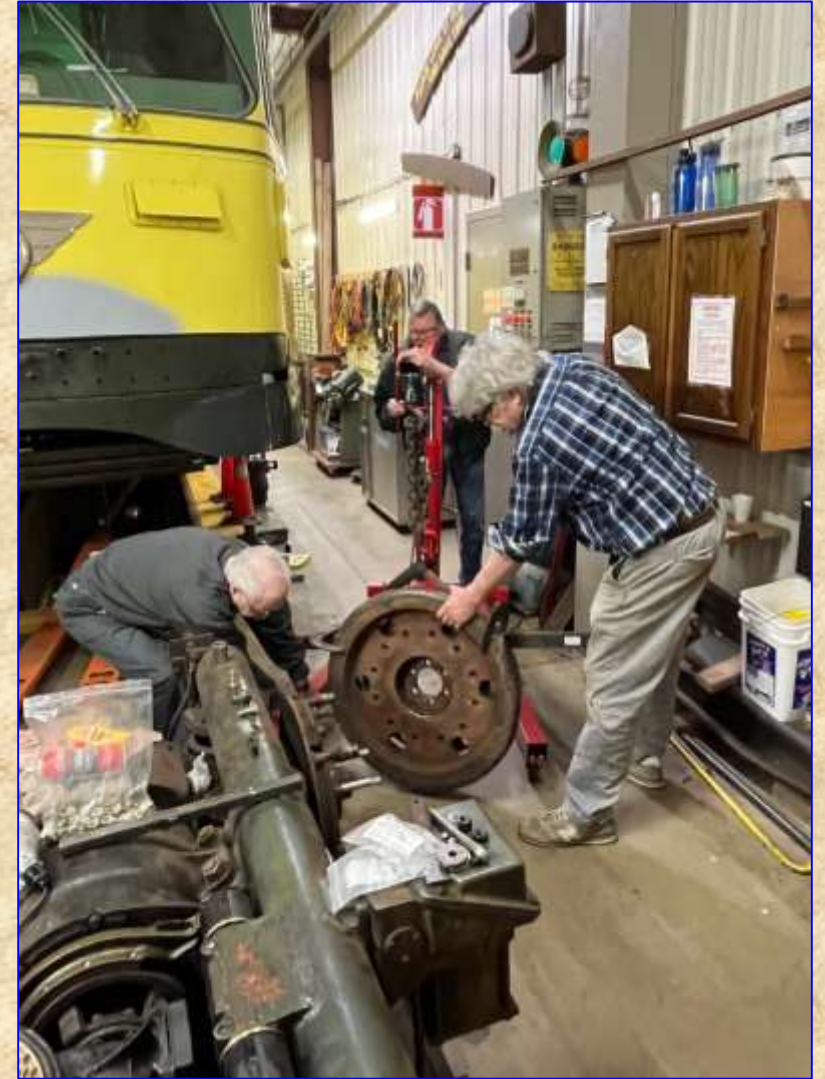
Wheel re-installation made easier with engine hoist; axle 2, front truck, pole side

Mark Digre, John Prestholdt and Russ Isbrandt manipulate the wheel

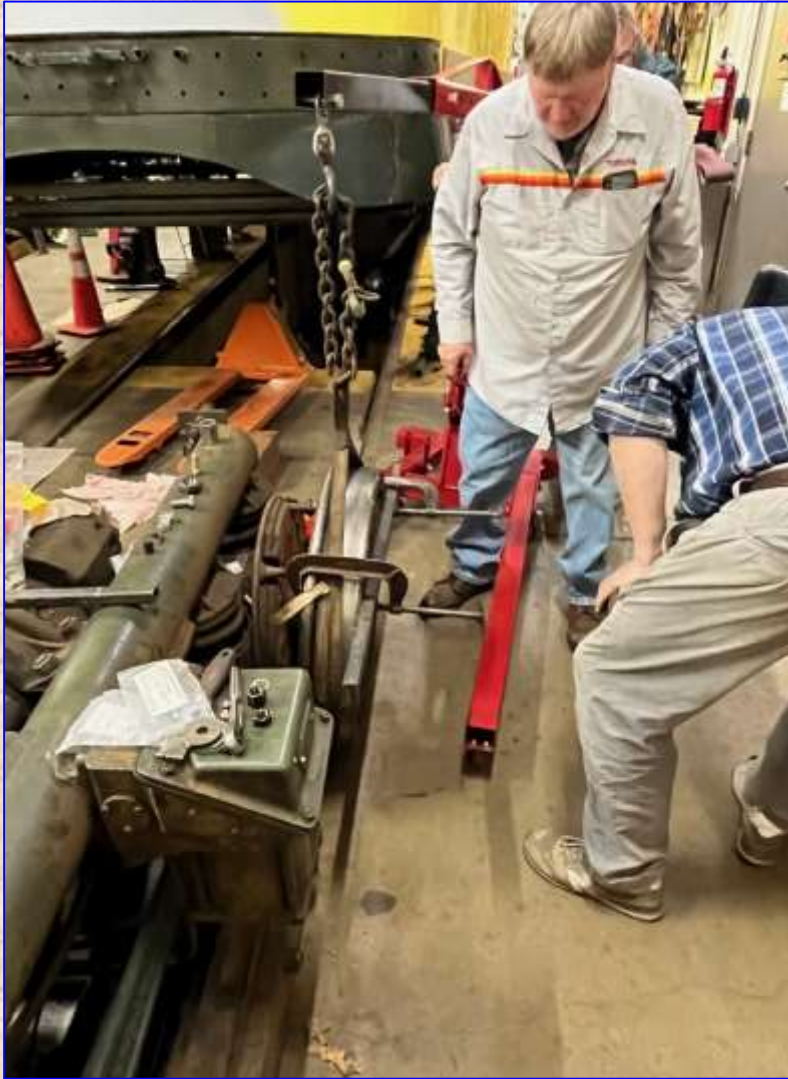
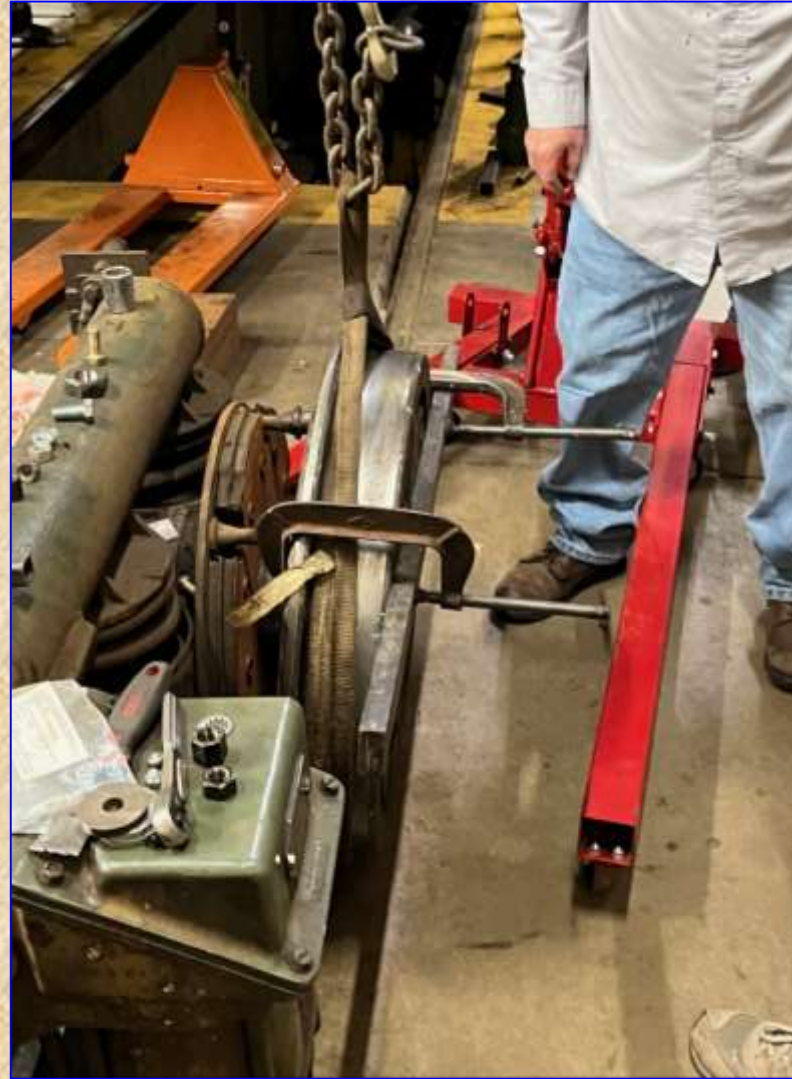
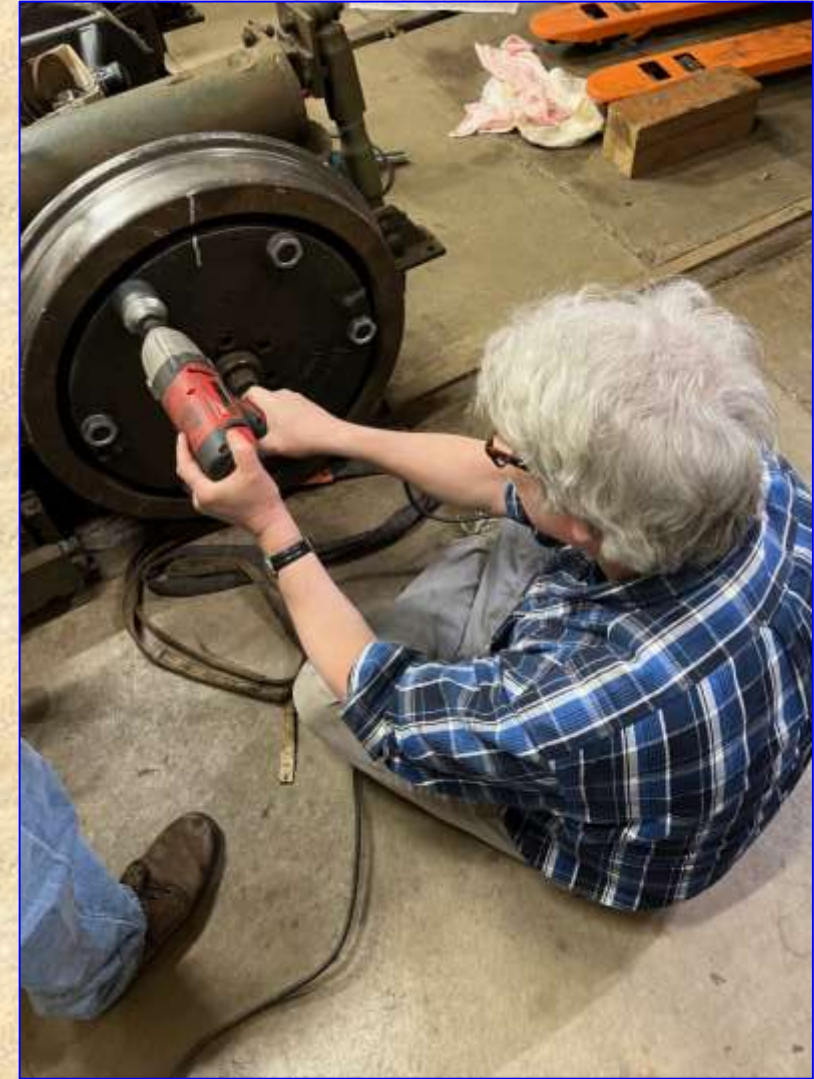
Bars and clamps maintain wheel assembly alignment; Tom Schramm and Mark Digre

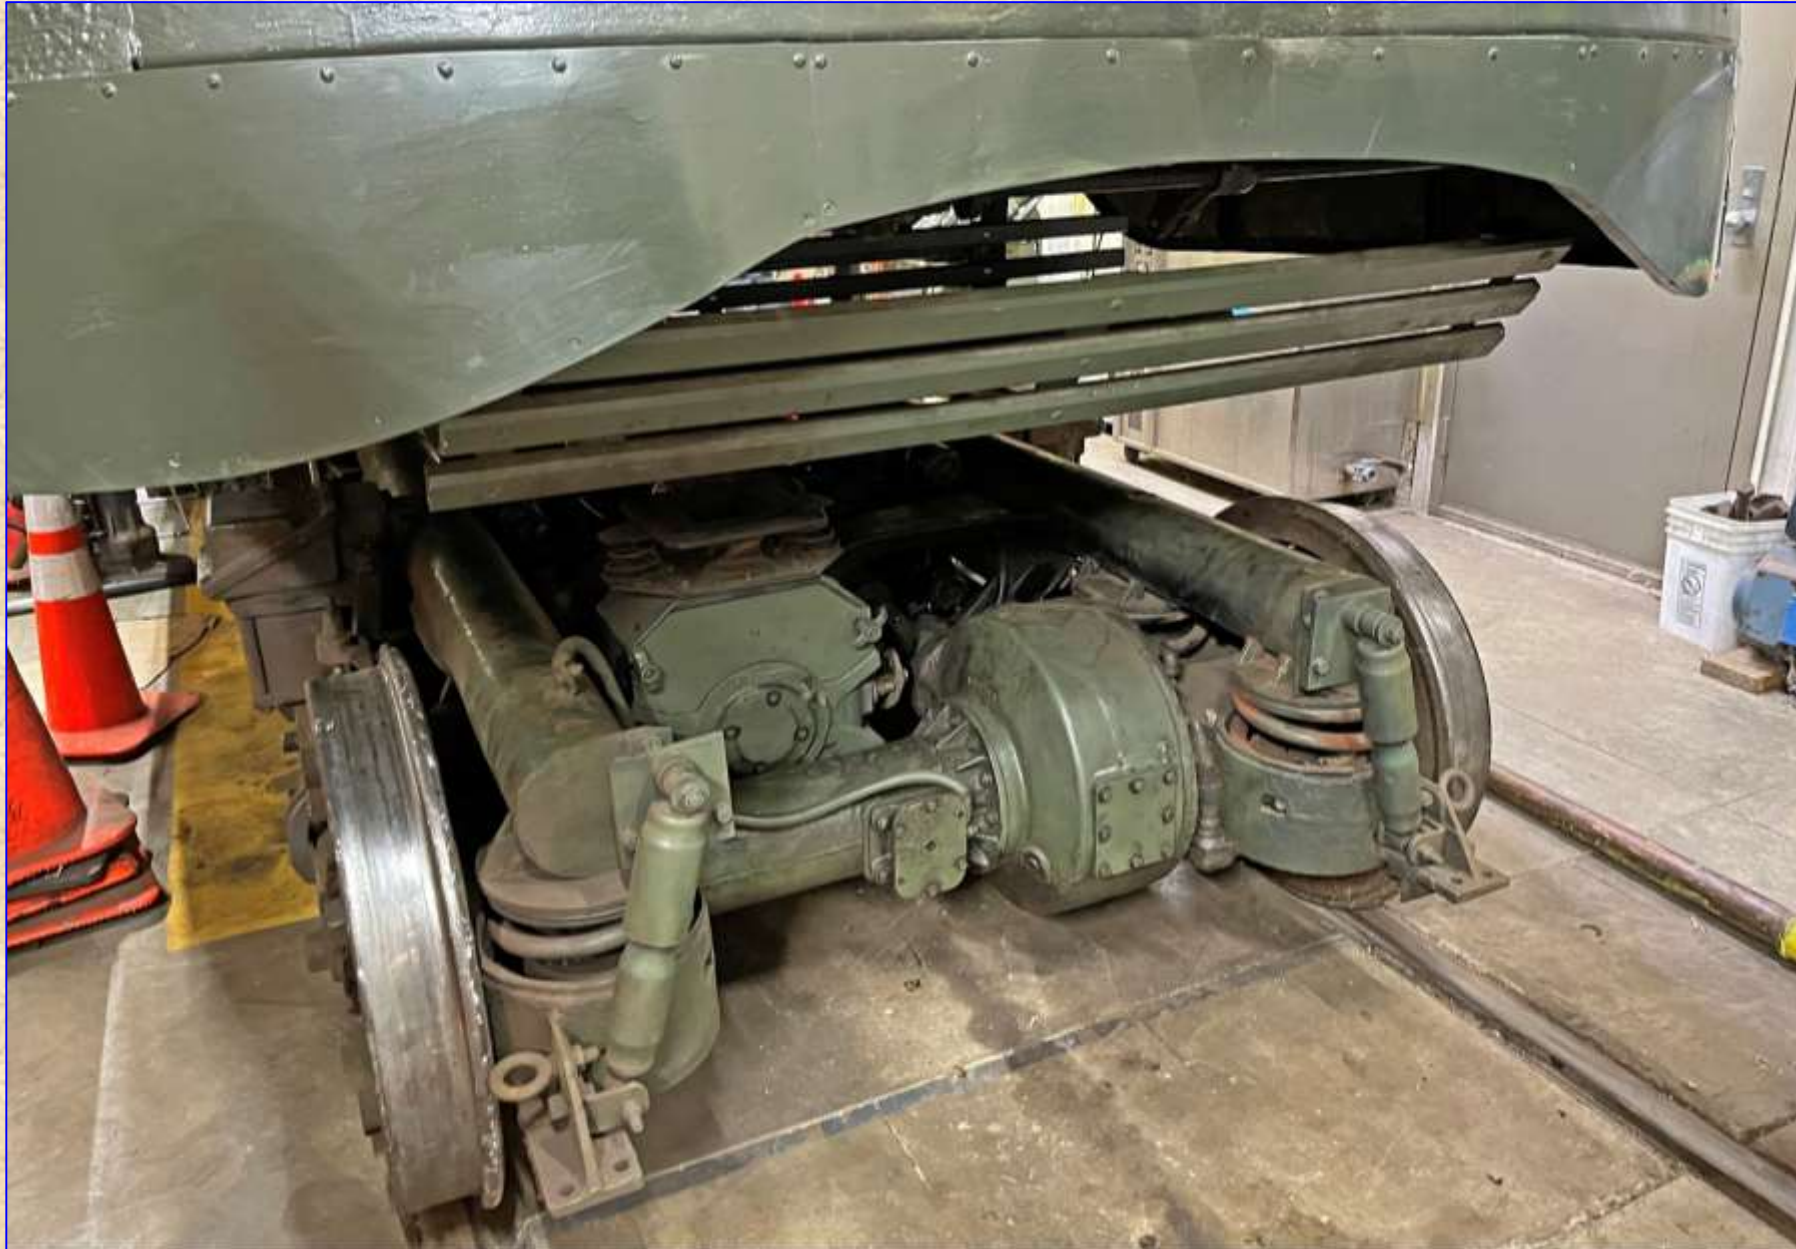
Rolling in the front truck after torque arm repair
