Streetcar CURRENTS

SPECIAL PHOTO SUPPLEMENT
January – 2023

Mesaba Railway No. 10

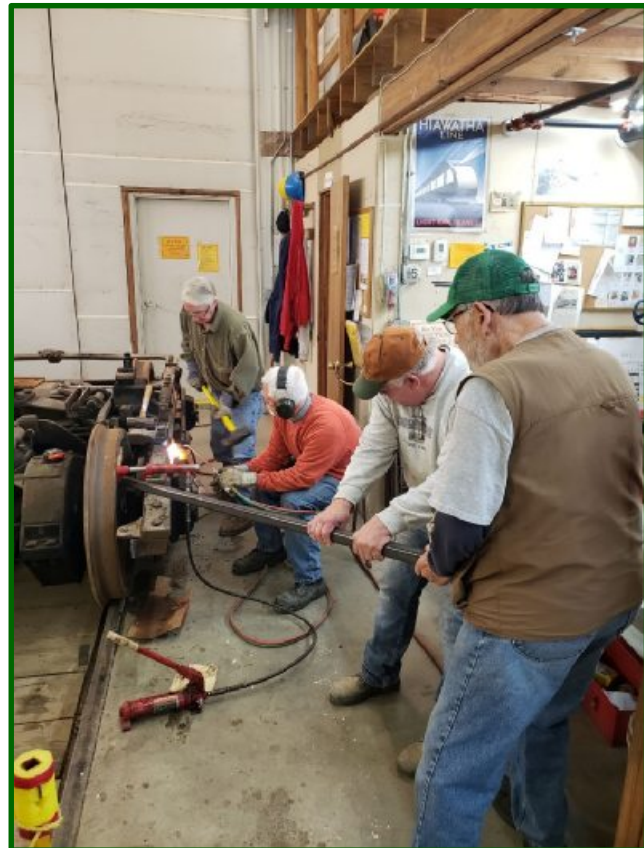
(Right) Both Baldwin trucks were built under license in Kobe Japan. During shipping to the U.S., the frames were bent. To get both trucks back to operational condition, the frames needed to be straightened. Here we see **Howie Melco** heating part of the truck's frame while **Scott Wardrope** uses a mallet to straighten it. **Scott Heiderich** and **Dick Zawacki** use a bar to apply pressure to the frame to help the process.

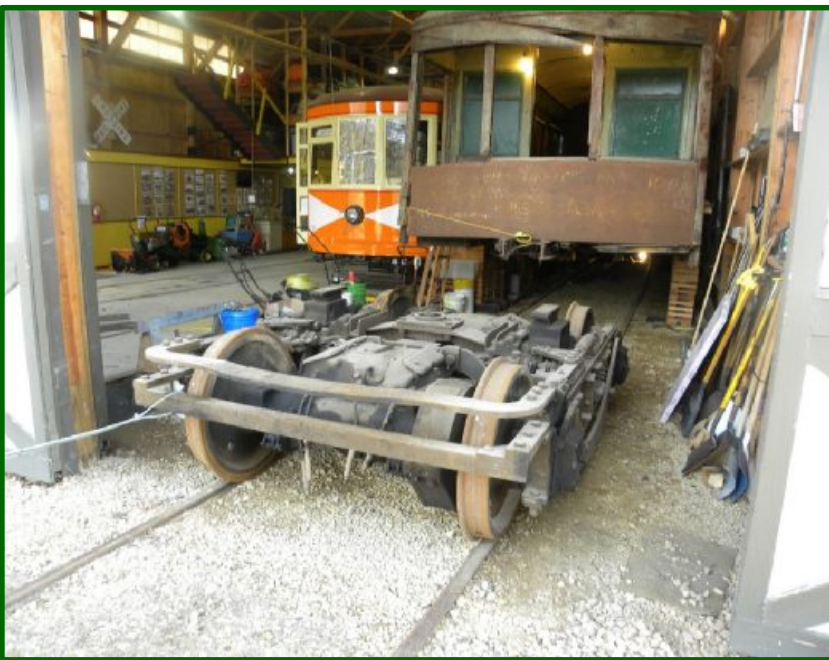
(Above) One of the two trucks stored under the Mesaba No. 10 carbody is pulled out from under it in preparation for cleaning and straightening in the warm barn. Notice the wooden "cribbing" that supports the car and holds it off the ground. Mississippi Valley Public Service Company No. 10, a single-truck streetcar, is in the background on track #2. It ran in Winona, Minnesota from 1914 to 1938 and awaits a rebuilt motor so it can enter service, hopefully in 2023.

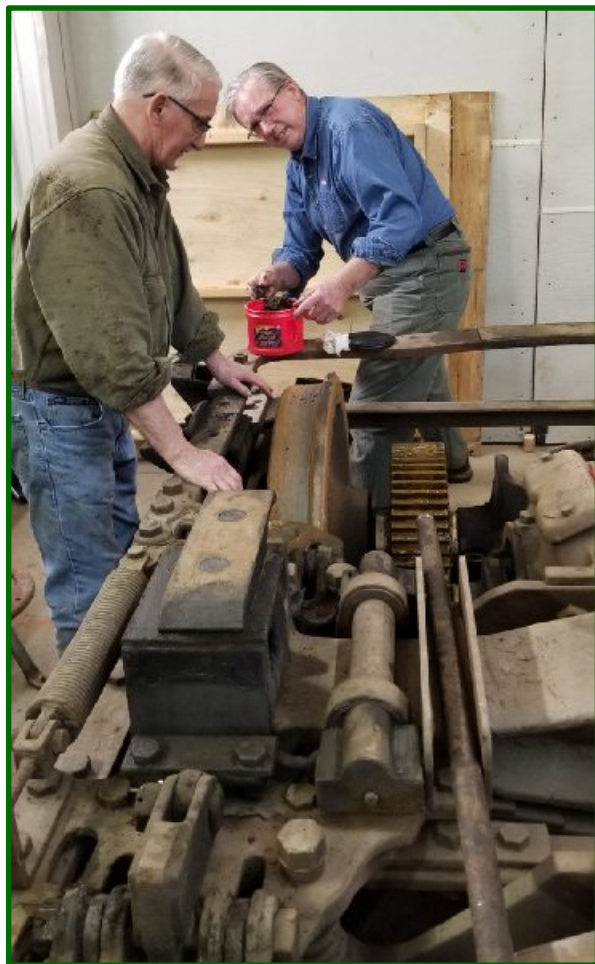
(Right) **Scott Wardrope** and **Jerry Draeger** are cleaning the dirt and grease from the truck components. Scott examines the wheel on one axle for wear and damage. The gear behind the wheel meshes with a gear on the motor to send the power to the wheels.

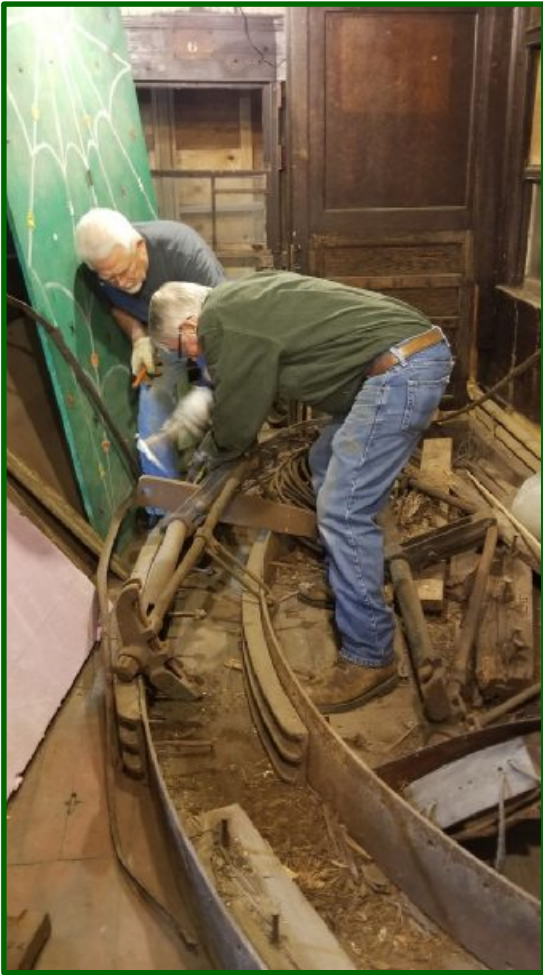
(Left) **Scott Wardrope** and **Howie Melco** are working on one of Mesaba No. 10's anti-climbers (a.k.a. "bumper") that was stored inside the car. Many other parts from the car and other cars, plus miscellaneous building materials, were haphazardly stored in the car.

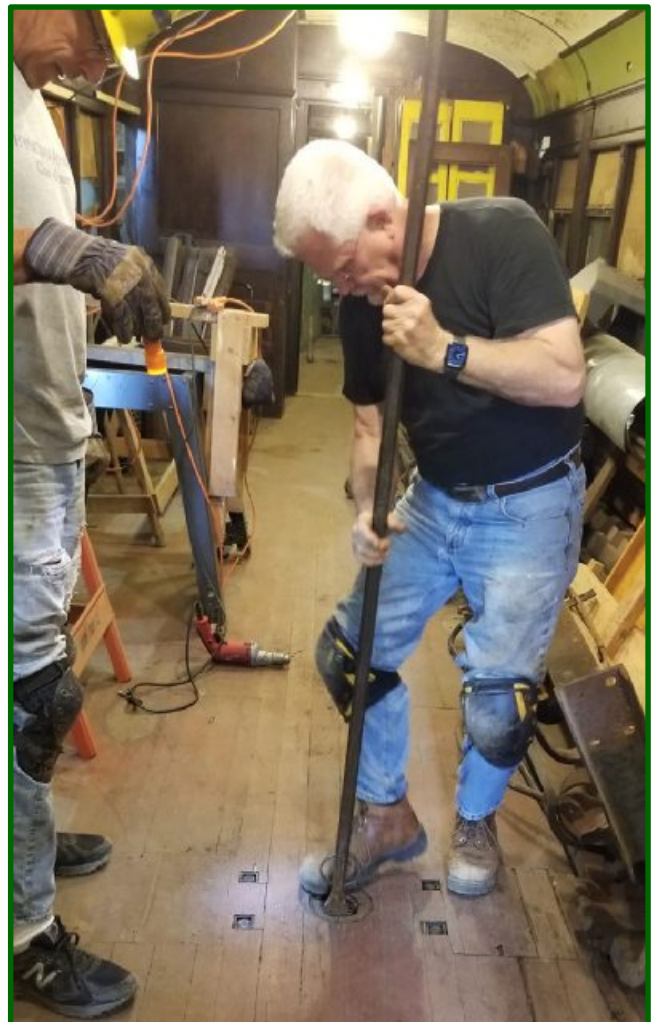
(Right). **Carl Floren** helps **Howie Melco** align the carbody bolster to a hole in the front truck's bolster in preparation for installing the front kingpin. Other ESL shop crew volunteers are under the car moving the truck into the correct position to allow the kingpin to drop into place.

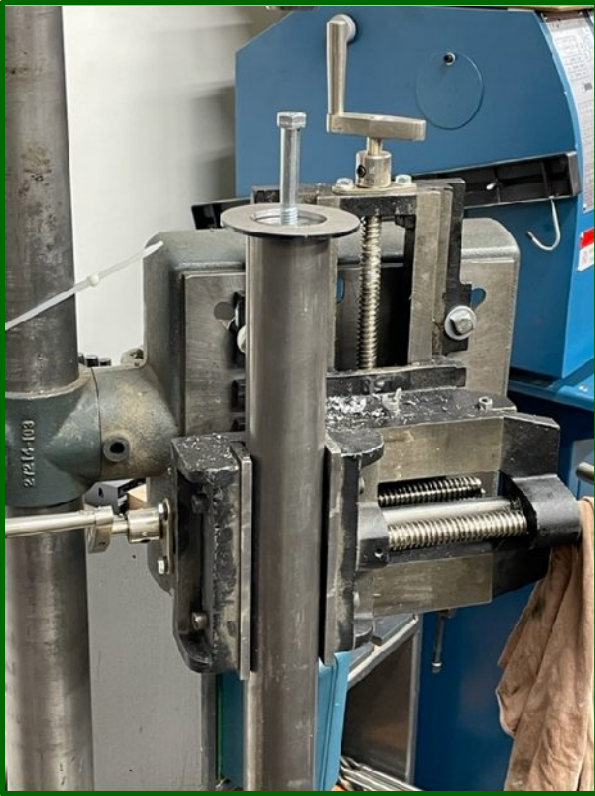
(Left) New kingpins were needed to align and hold the truck and carbody to each other. A hole needed to be drilled and threads tapped to one end of the pin. Here one of the pins is held vertically on a drill press table to complete the drilling and tapping operations.

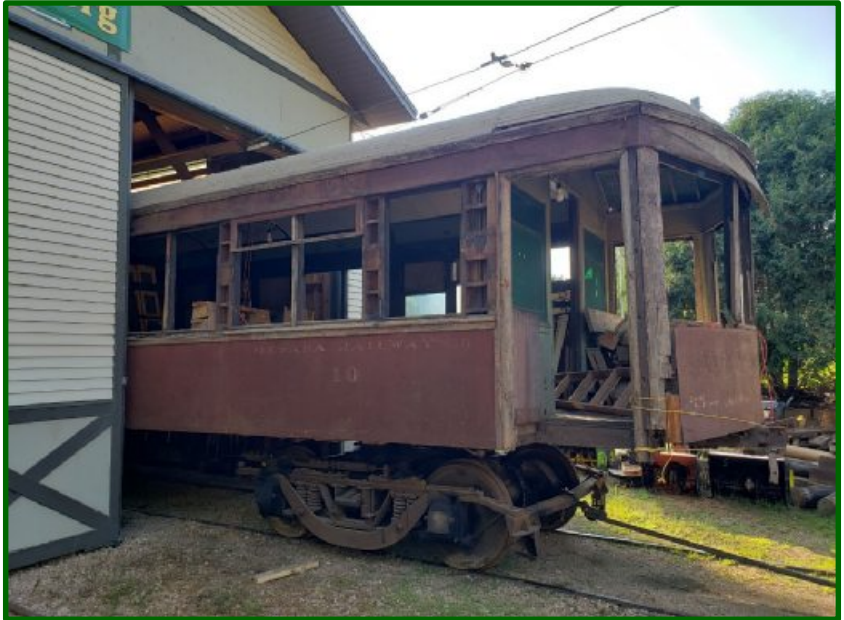
(Above) It was a tight squeeze to get Mesaba No. 10 out of the car barn, due to the misalignment of the track with the doors on track #3 and the curvature of the track outside the car barn. The car made it with less than an inch of clearance at one point. The misaligned track was one of the reasons for moving Mesaba No. 10.

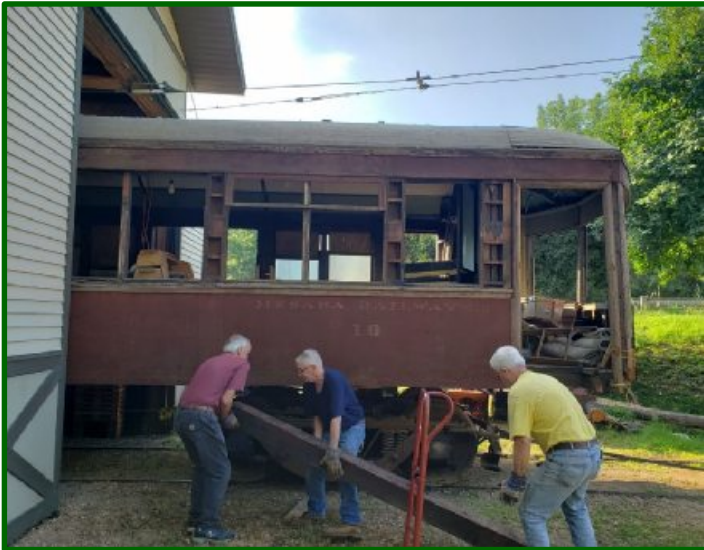
Jim Kertzman, Scott Wardrop, and Howie Melco prepare to put a tie under the car body to help stabilize and brace it during the move.

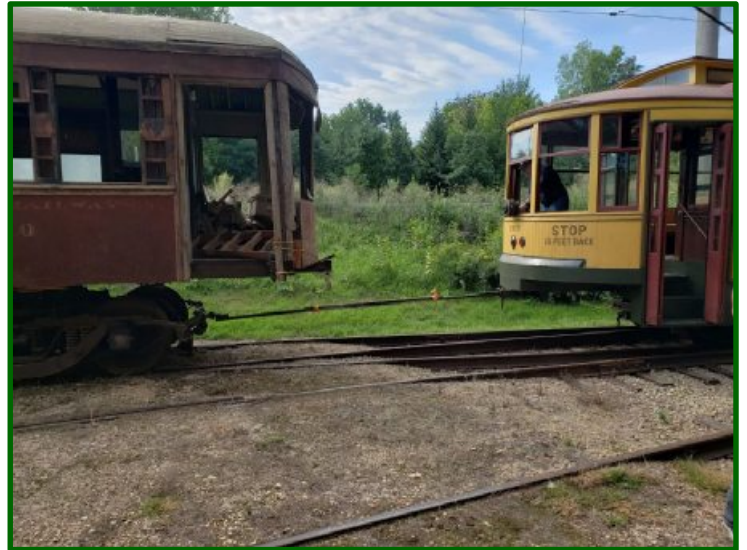
A strap was used between Duluth Street Railway No. 265 and Mesaba No. 10 to pull it out of the car barn on track #3.

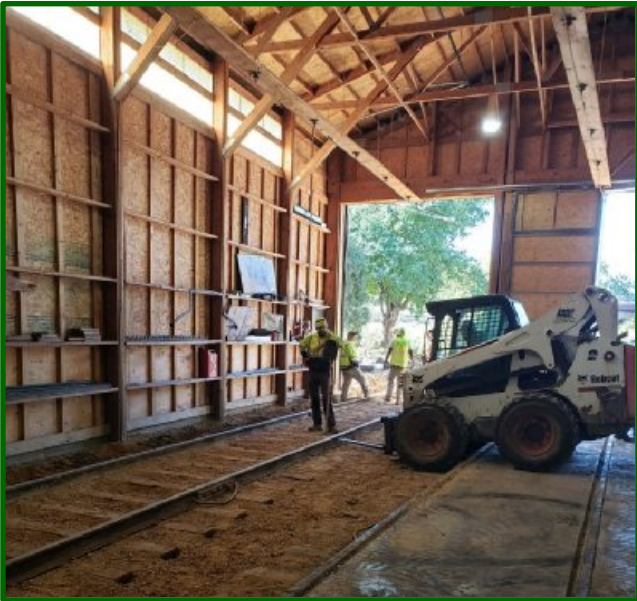
With everything cleared out from track #3, local railroad construction company Railroad Specialties Inc., began the process of aligning the track with the center of door #3. With the track now properly aligned, all the cars at ESL can safely access track #3. The next step is to finish the concrete floor around track #3, which was done in December 2022.

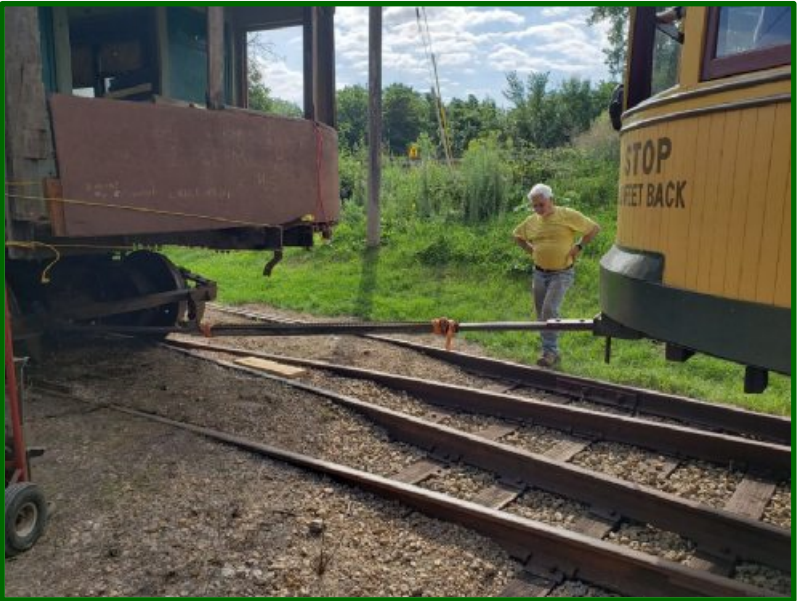
A tow bar was used to push Mesaba No. 10 into car barn track #2.

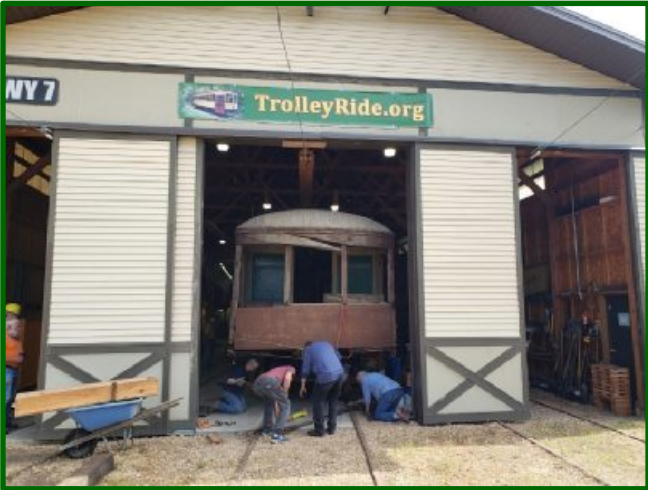
Several crew members examine Mesaba No. 10 as it resides in its new location on track #2 in the ESL car barn. The car is well centered between the doors and will now serve as a focal point for car barn tours. Future restoration work on the car is now being planned.
